Some Failures & Remedies

Jagadiswar M. Shrestha

Structural Engineer
shresthajm@hotmail.com

Some major causes of current Failures

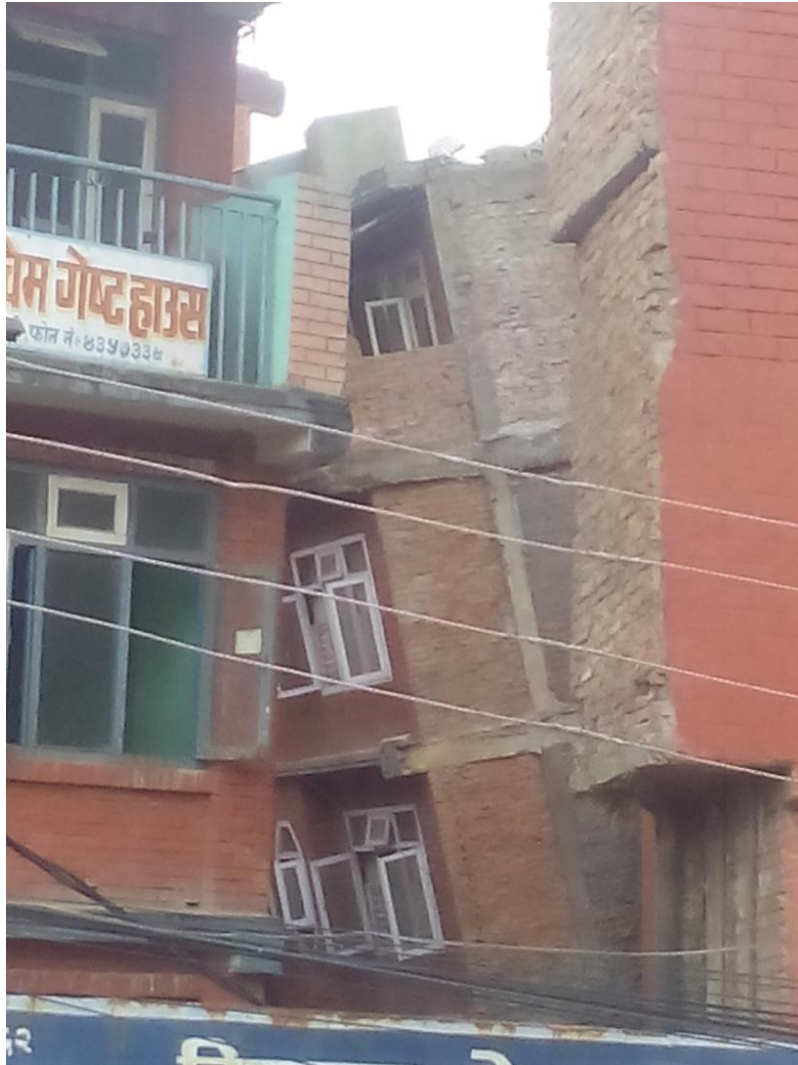
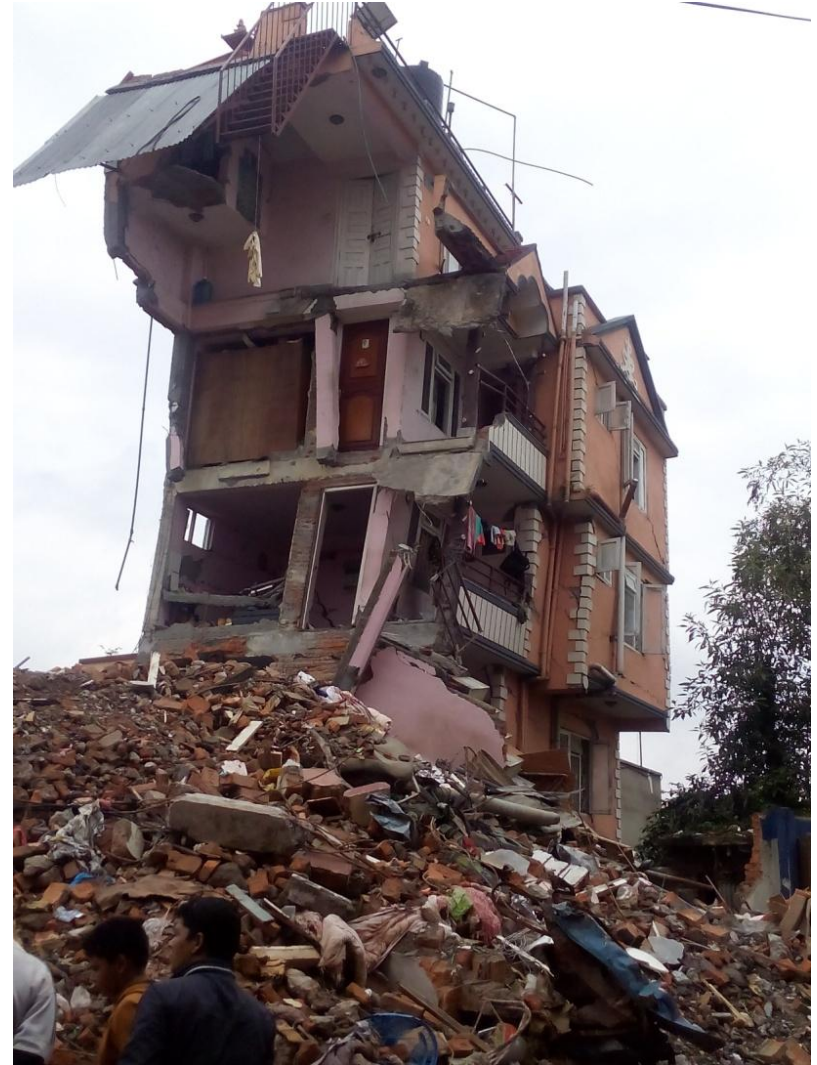
Differential settlement due to Soil condition

Building Structure at the same location (Macchapokhari, Balaju)

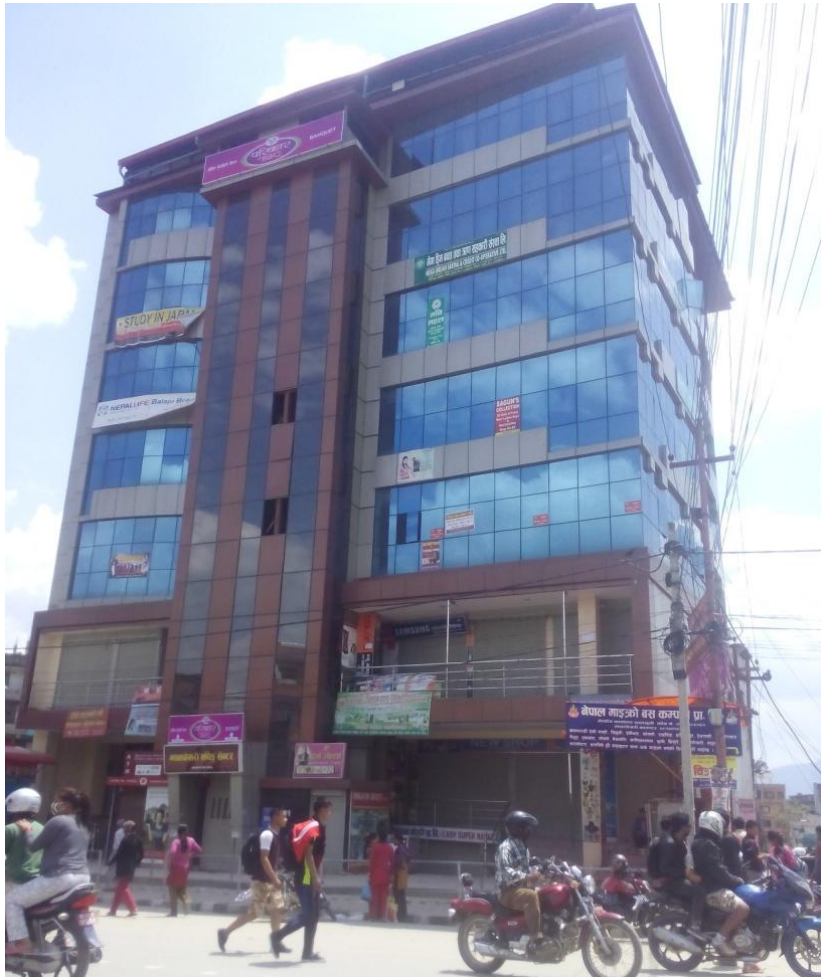
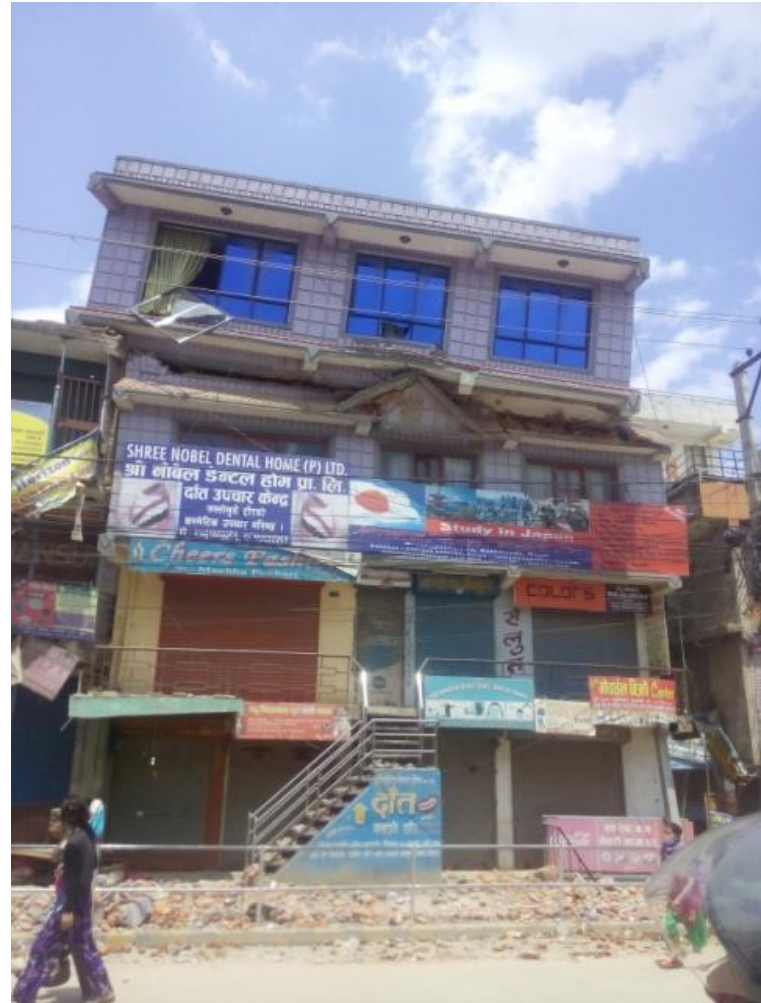
Failure near by Balkhu River

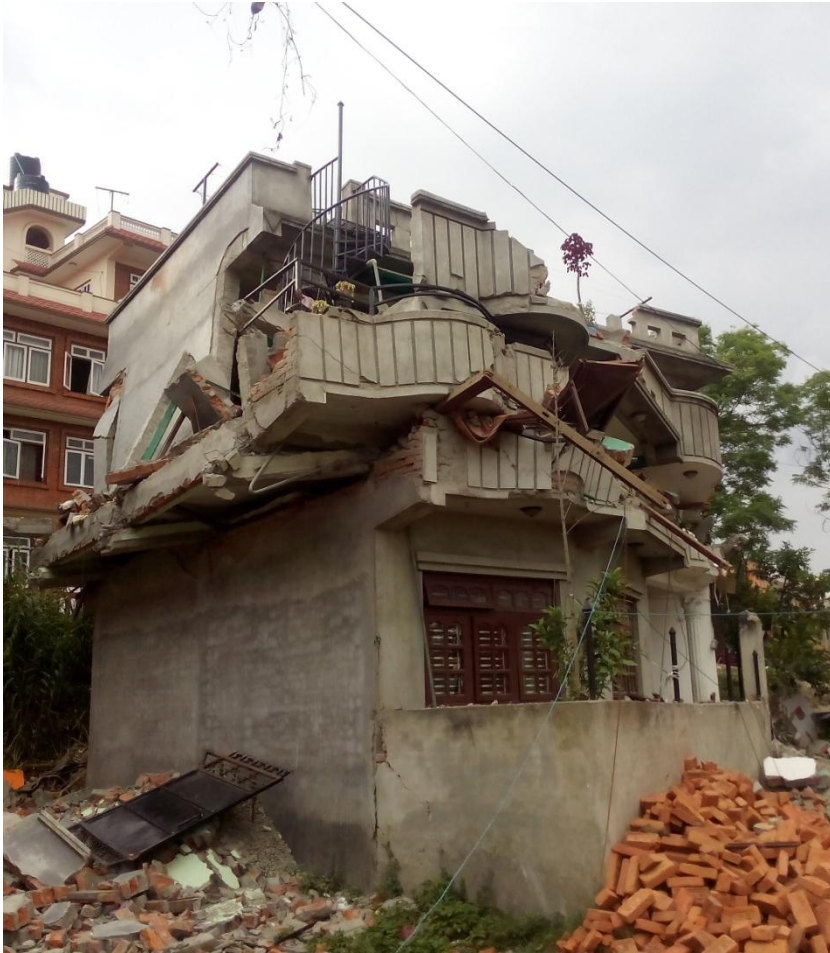
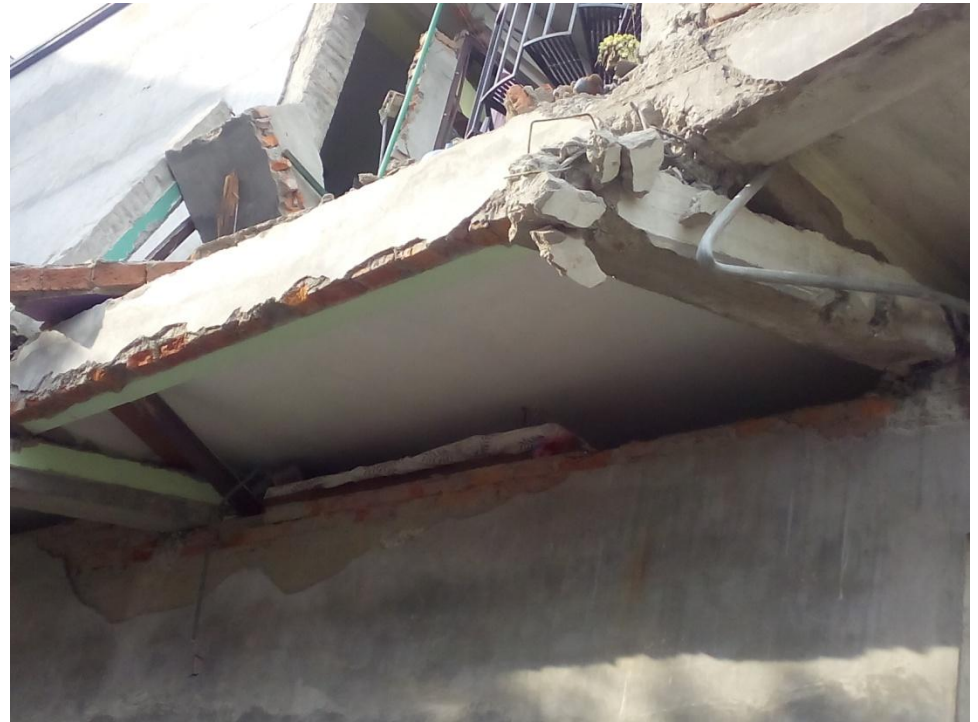
Failure near by Dhungedhara, Thamel

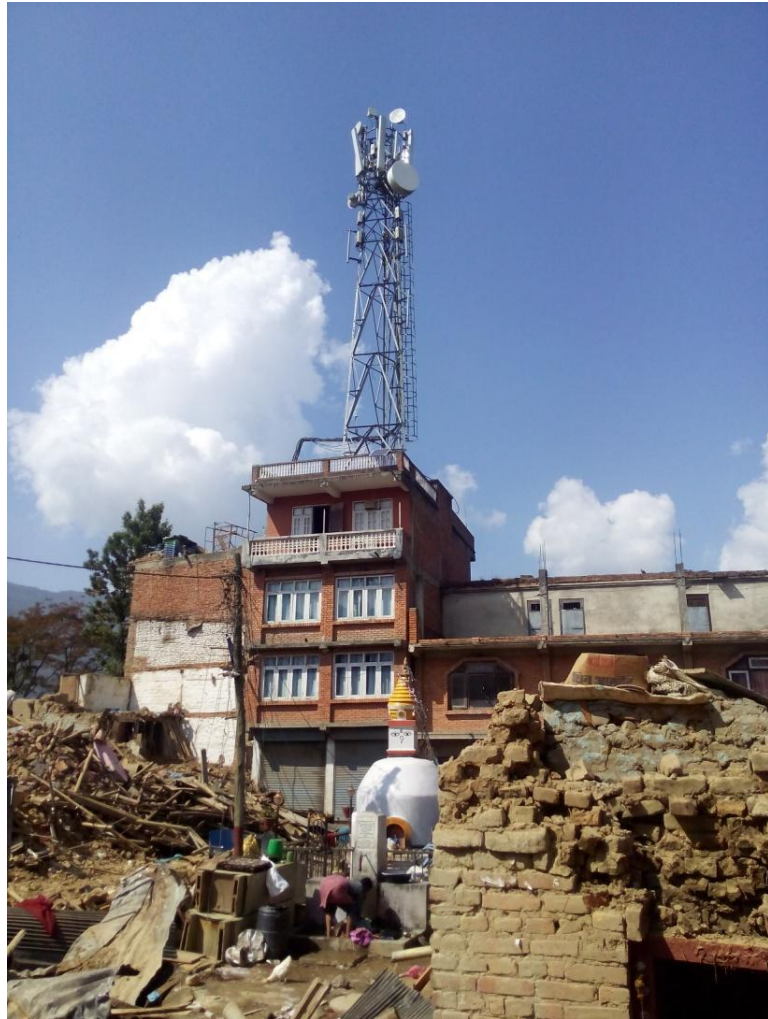
Framed Structure, Dharmasthali
(No damage)

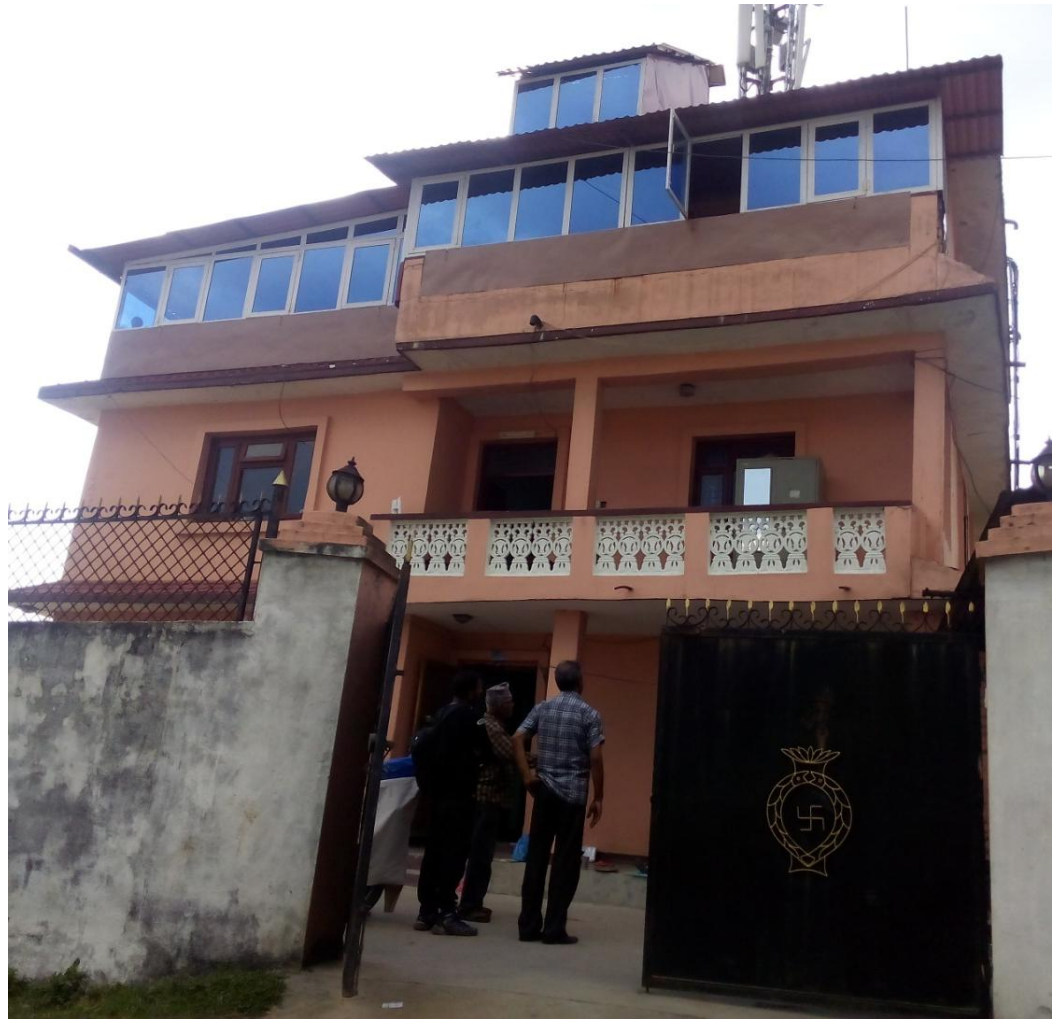
Wall bearing Structure, Kapan3
(Totally damage)

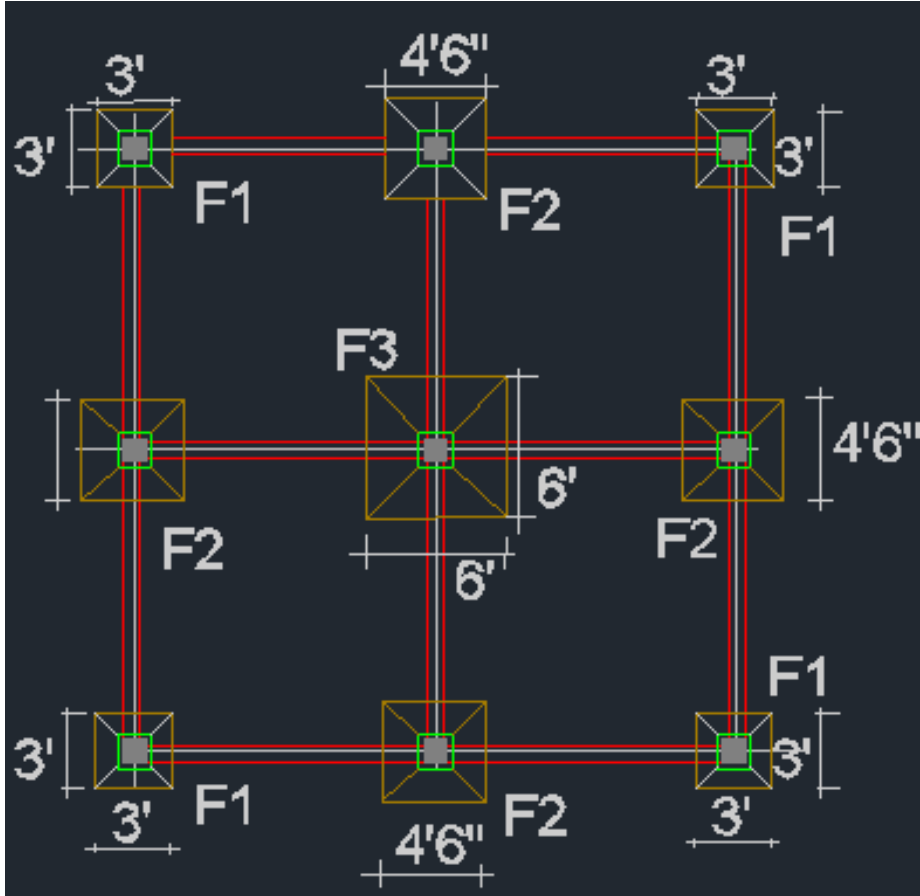
Differential settlement due to Lack of Foundation Design

Footing Design for Ideal Case

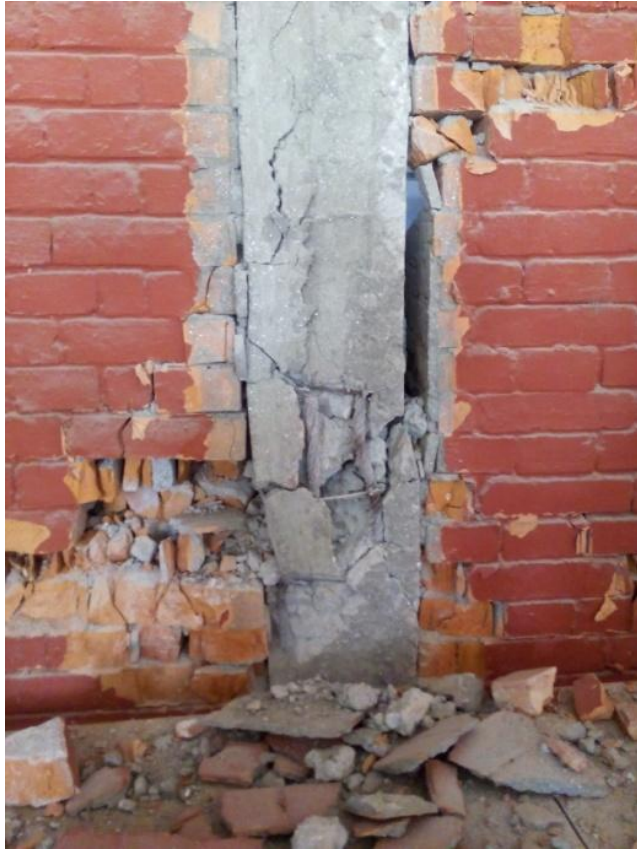
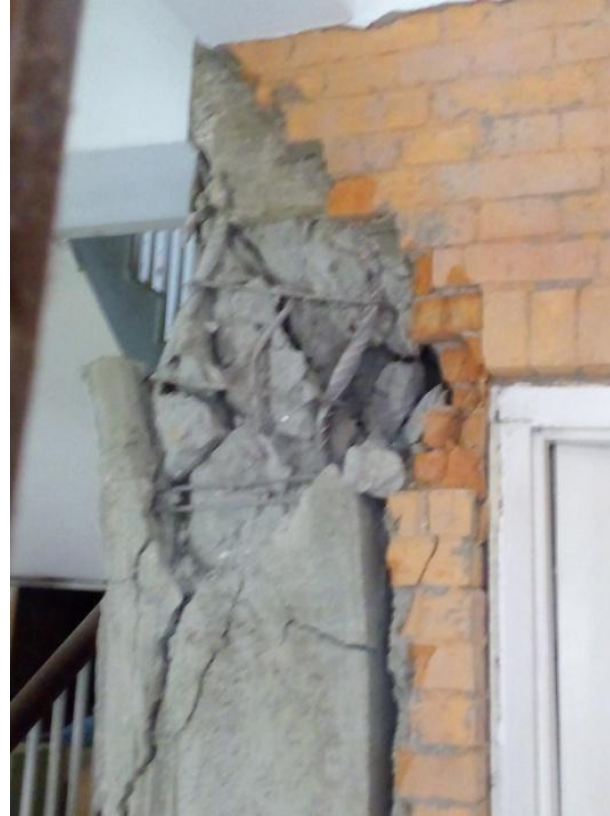
Poor quality of construction material & Lack of application of Detailings

Lack of lateral ties & hook requirement

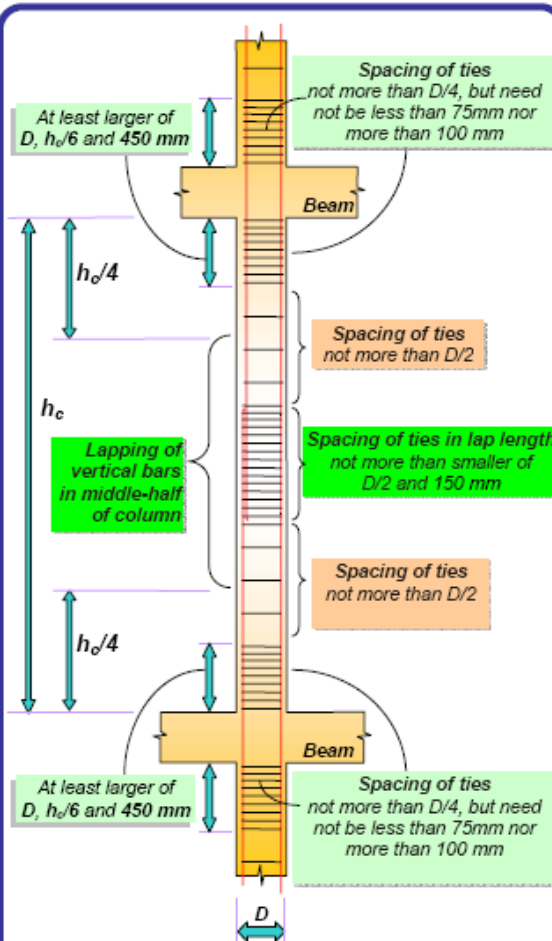
Poor quality of construction material & Lack of application of Detailings (IS 13920:1993)

Figure 4: Placing vertical bars and closed ties in columns – column ends and lap lengths are to be protected with closely spaced ties.

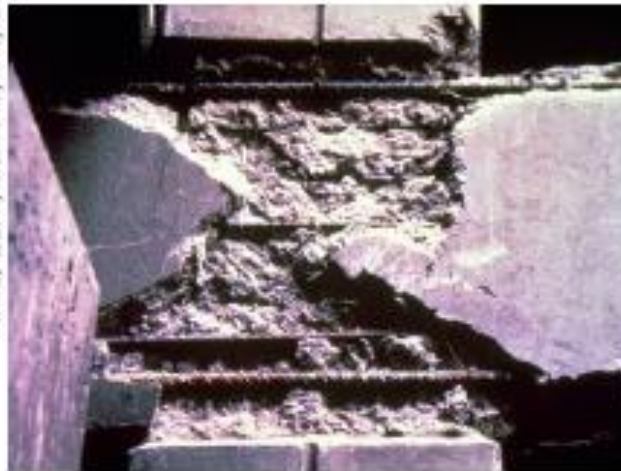
Shear failure of RC beam-column joint during the 1985 Mexico City Earthquake, when beam bars are passed outside the column cross-section

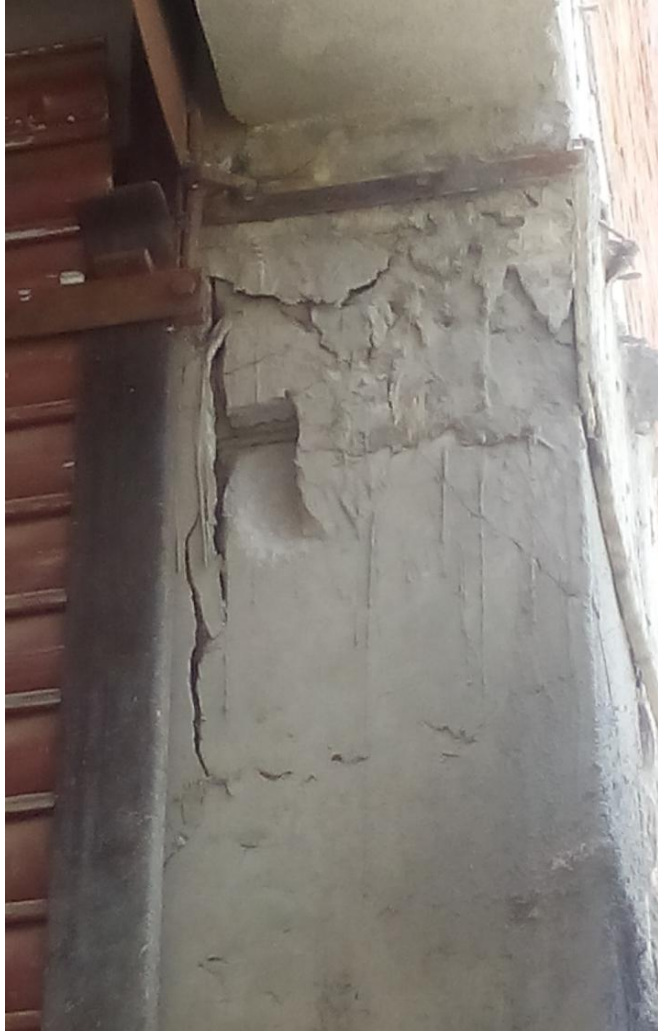
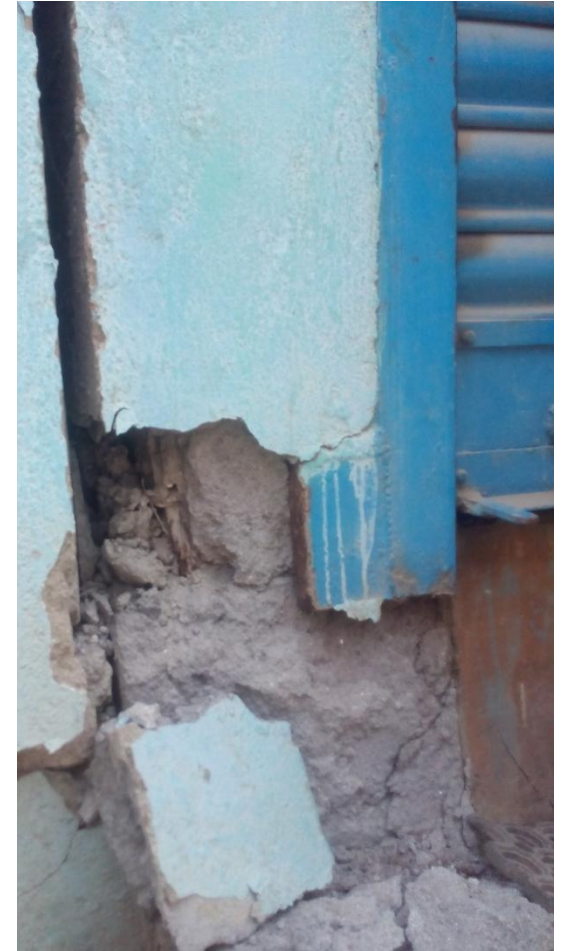
Poor Quality of Construction

Shutter connection with Column

Proper fixing of Shutter

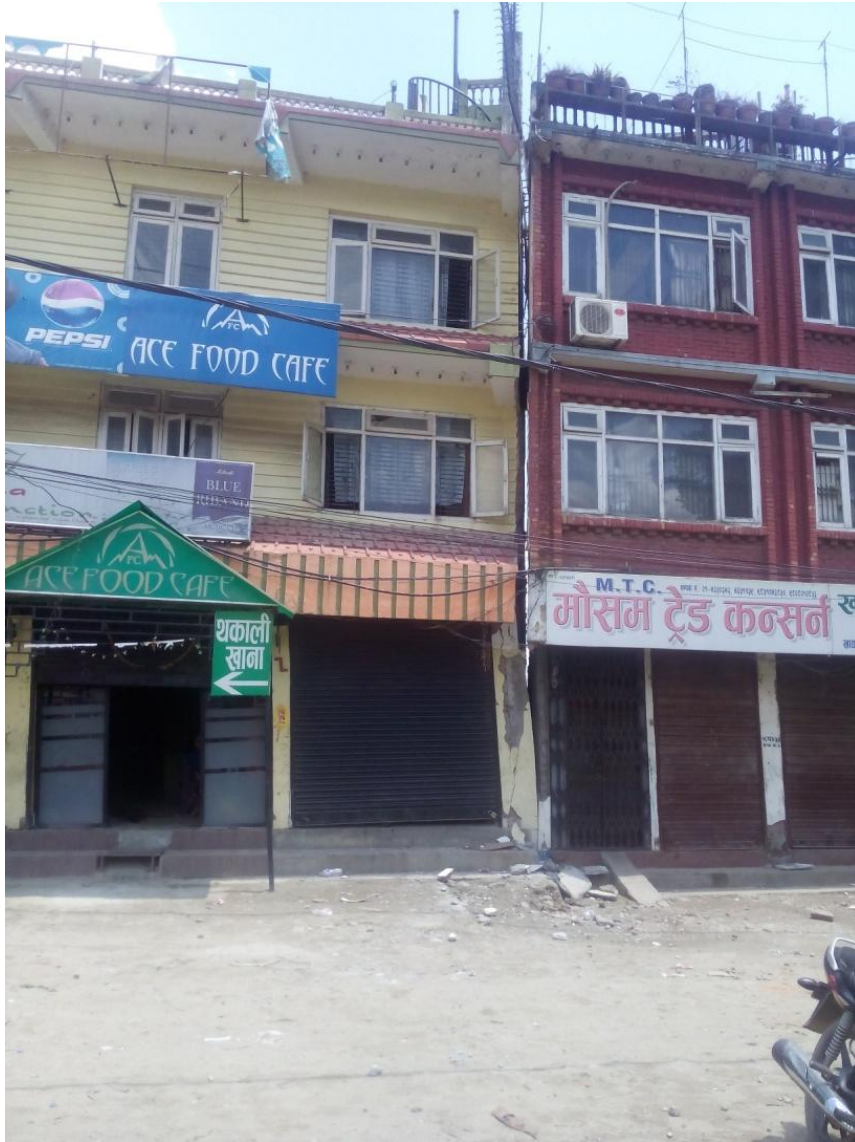
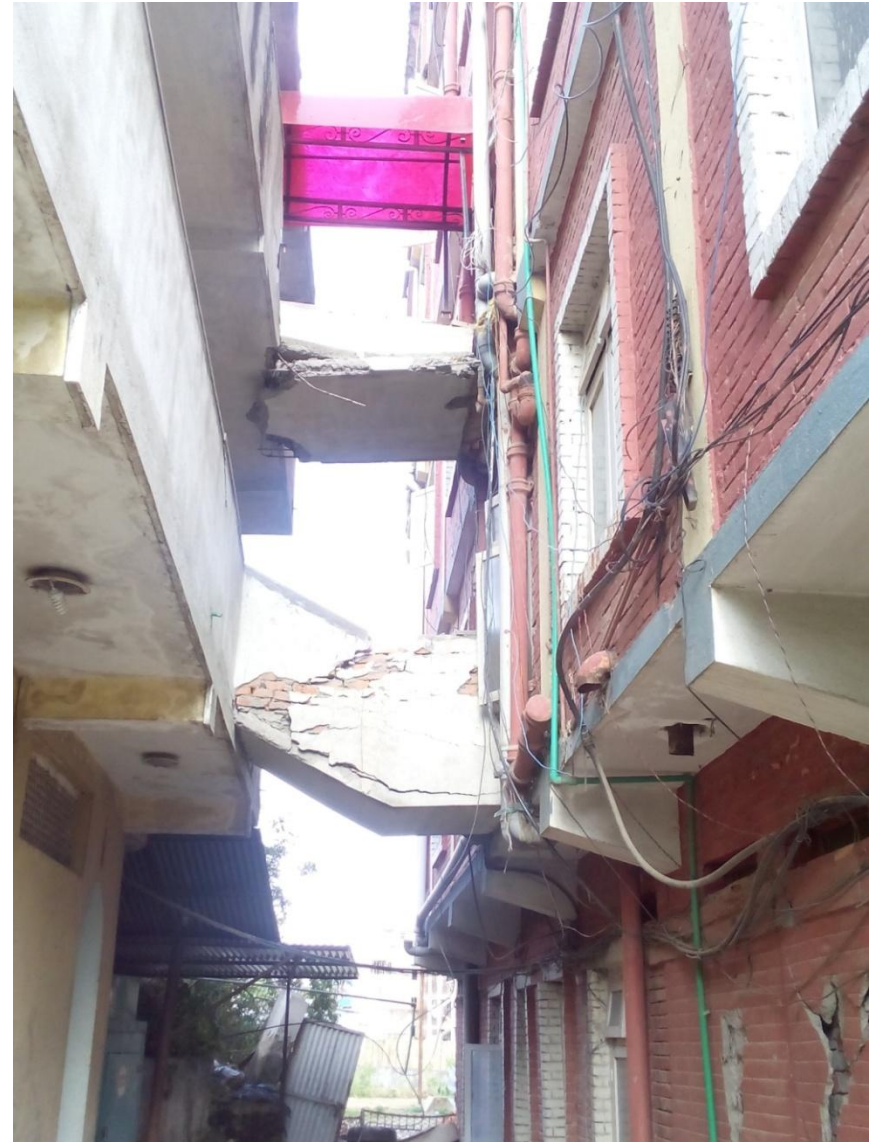
Adjacent building joint consideration (pounding effect)

Building Attachment Failures

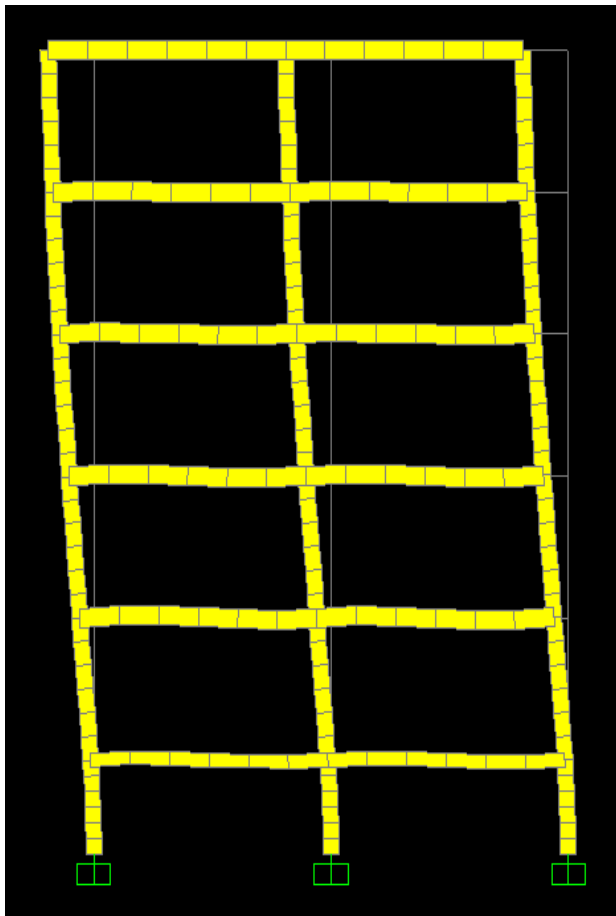
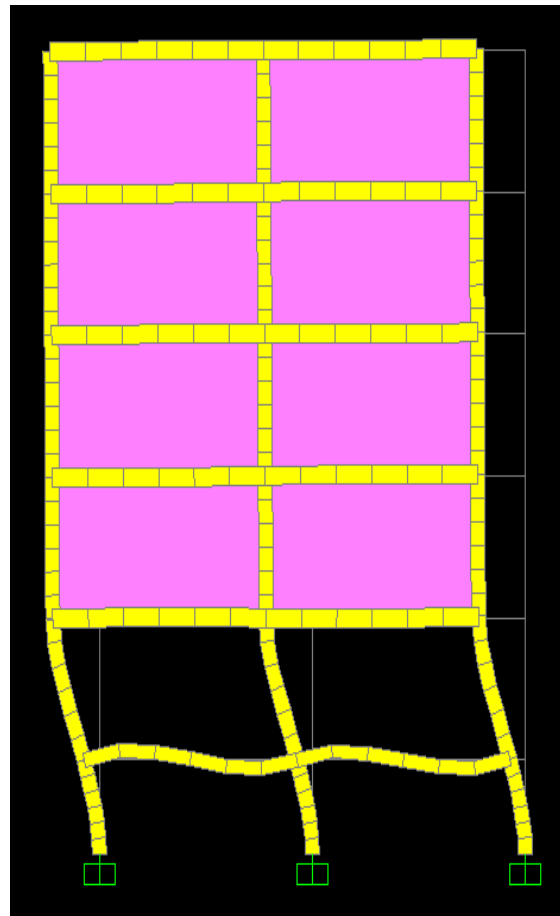
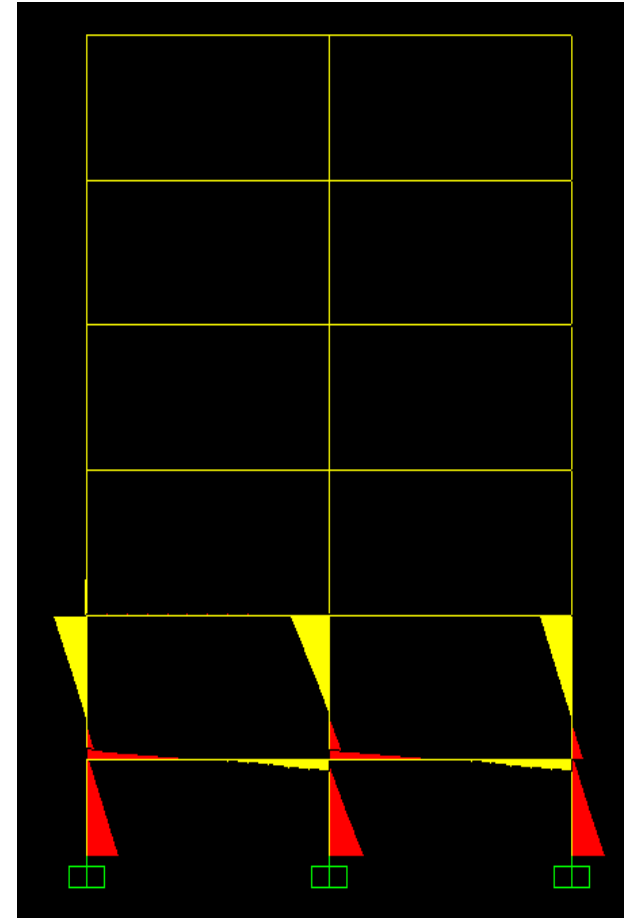
Soft Storey Effect

Normal Frame with inactive filler wall

EQ Force

Deformation

Moment

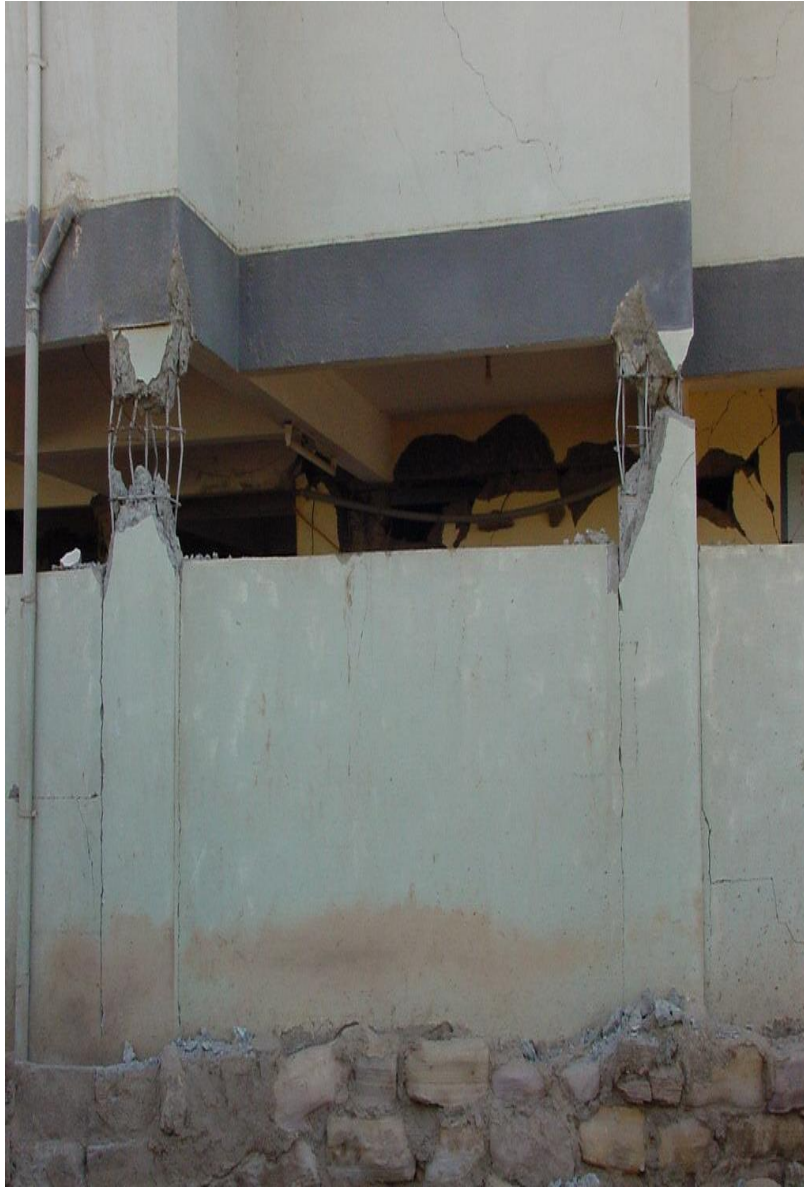
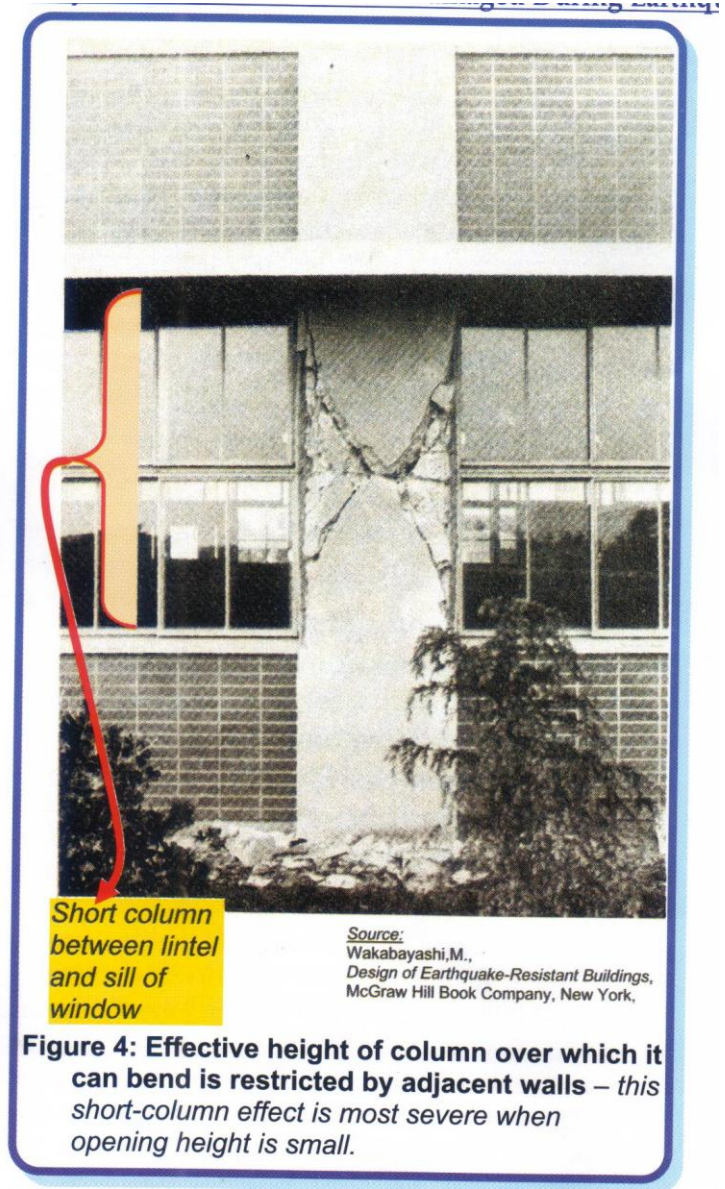
Short Column Effect (Increment in Relative Stiffness, EI/L)

Short column
between lintel
and sill of
window

Figure 4: Effective height of column over which it can bend is restricted by adjacent walls – this short-column effect is most severe when opening height is small.

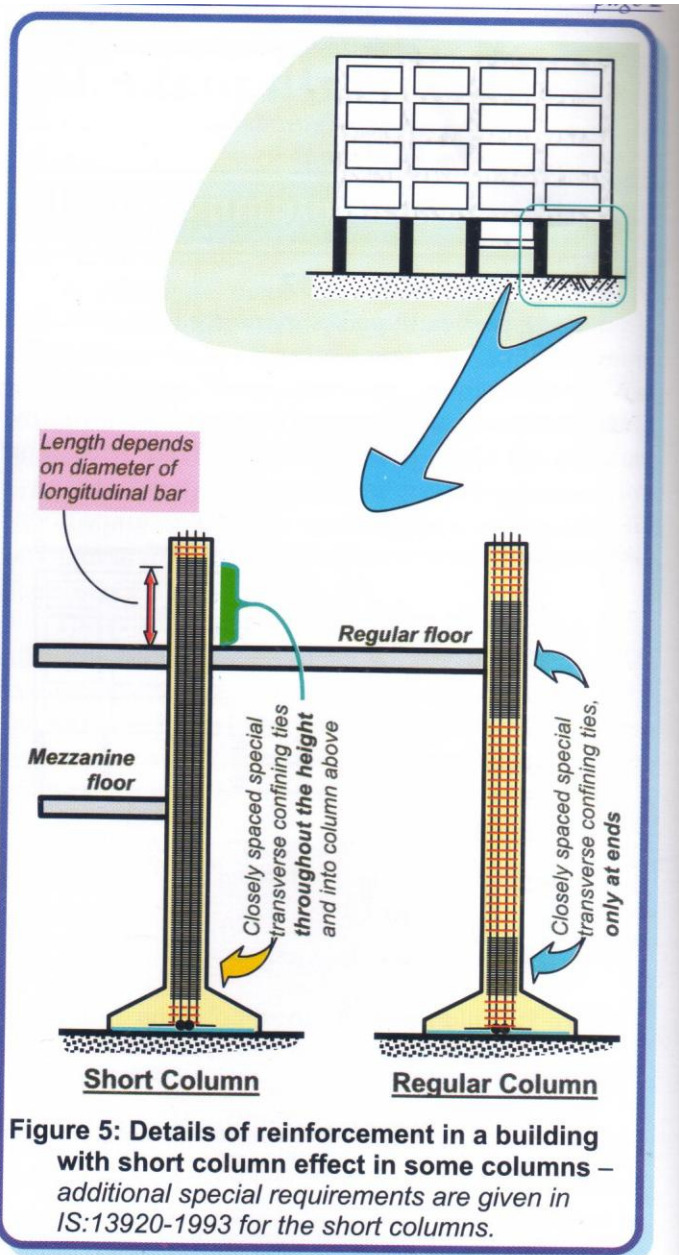
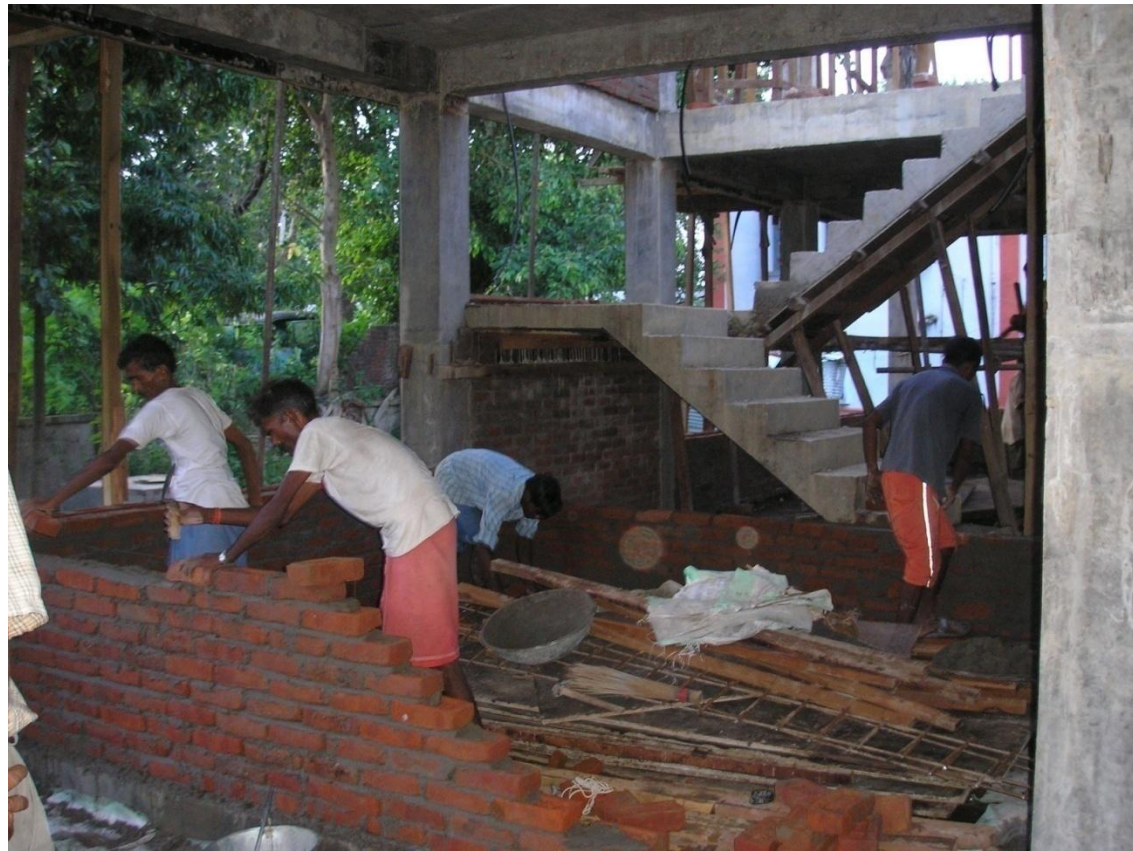
Short Column Ties & Elimination of its effect

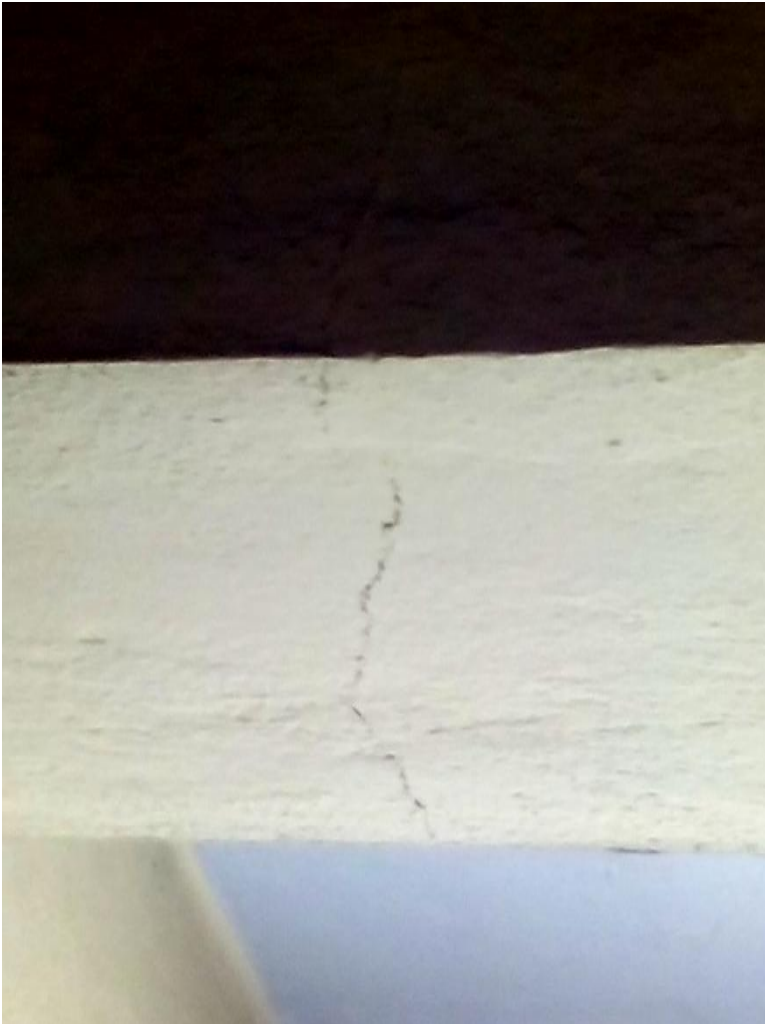
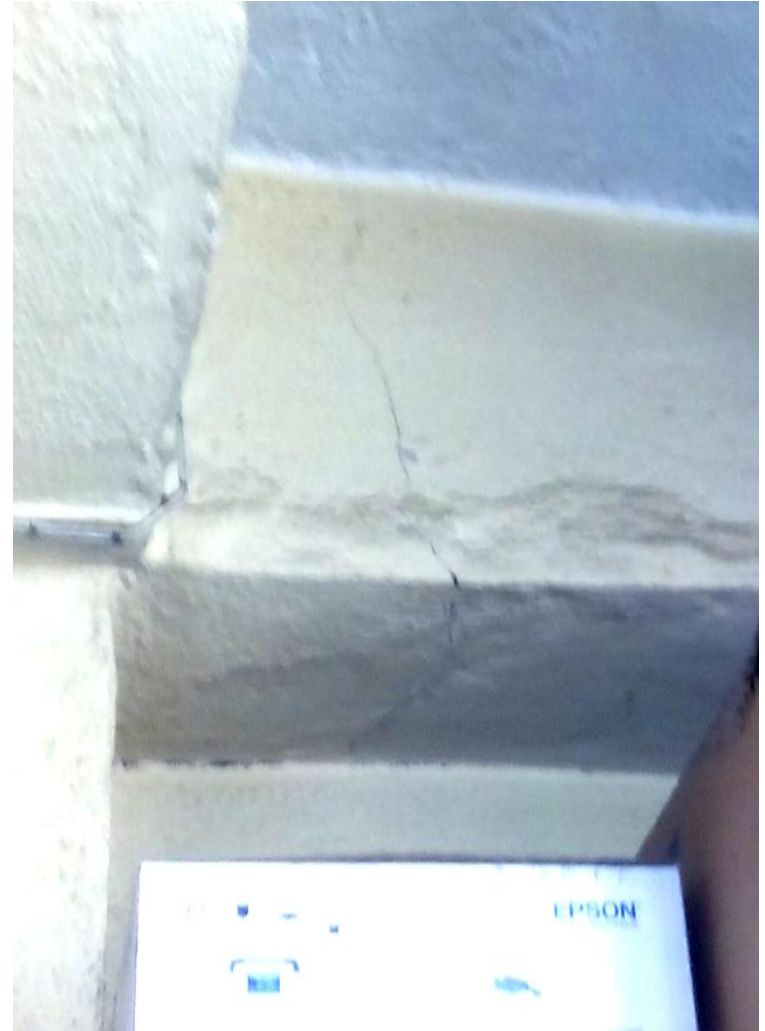
Vertical Cracks in Beam

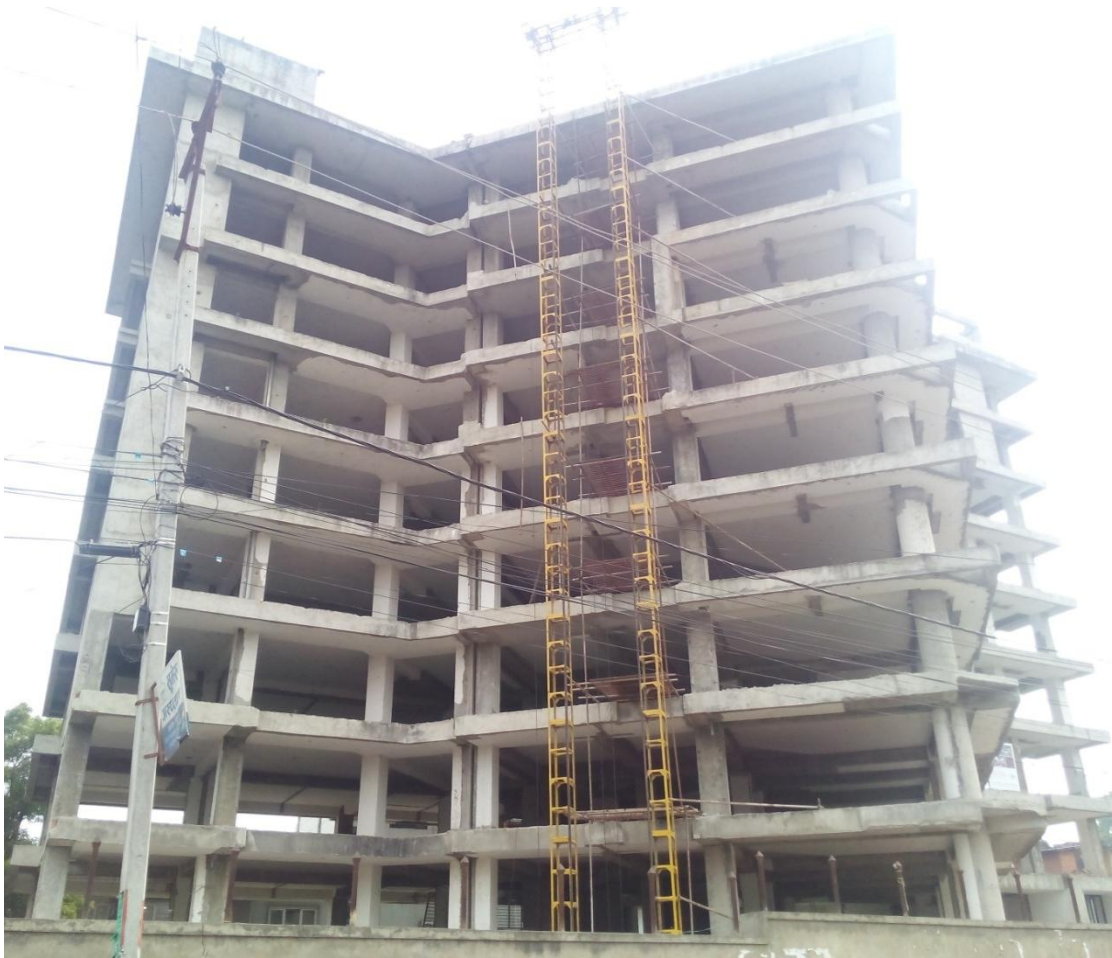
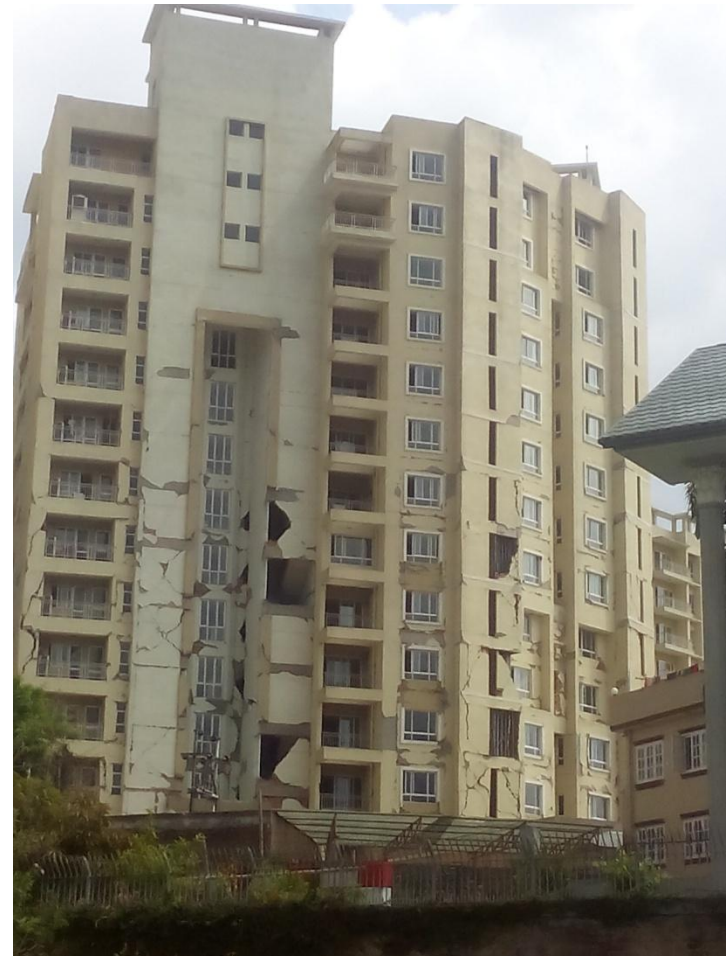
Breakdown of Infill wall

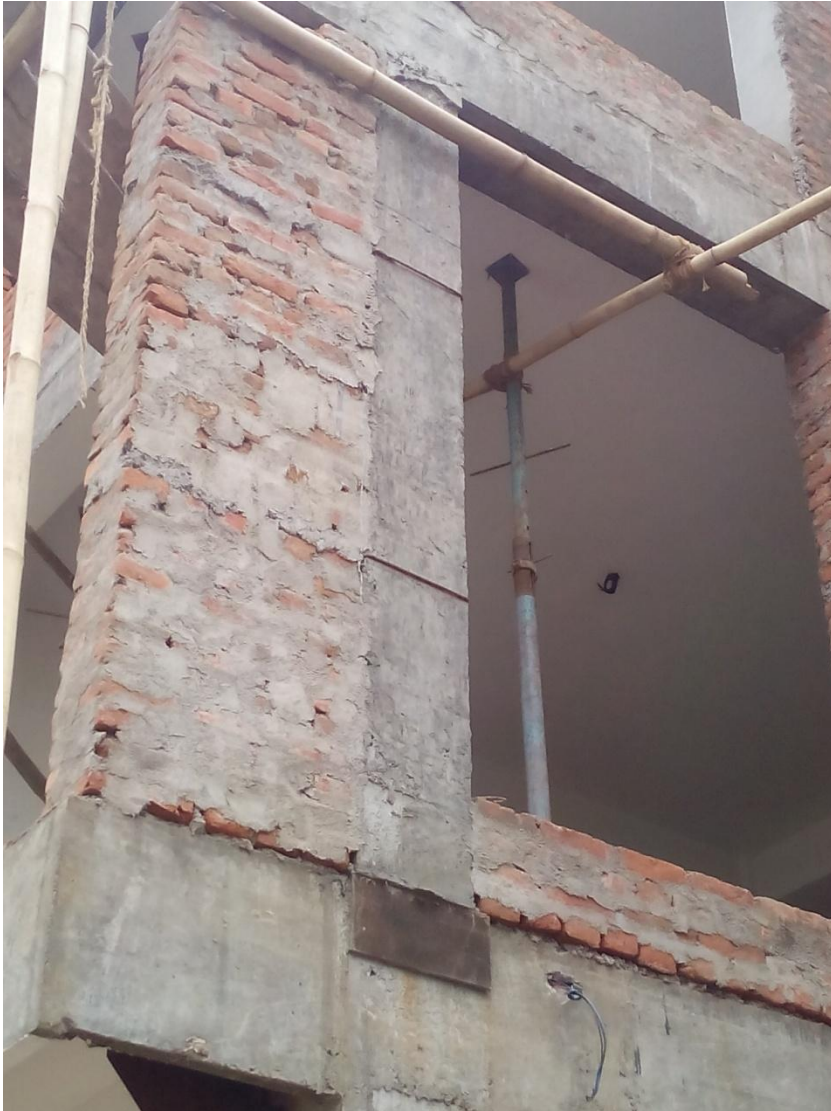
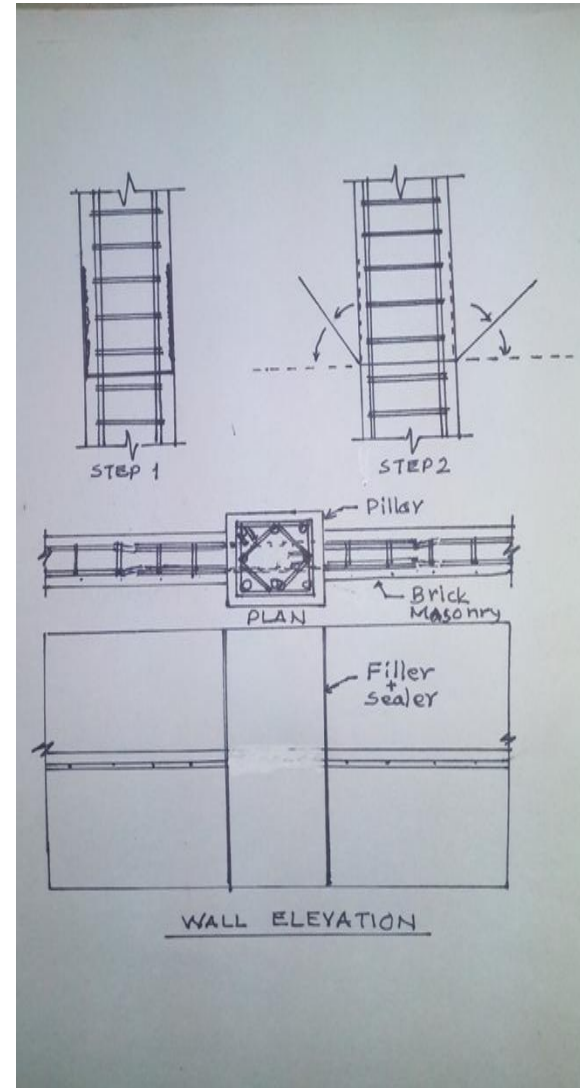
Infill wall connection
