Some Failures & Remedies

Jagadiswar M. Shrestha

Structural Engineer
shresthajm@hotmail.com

Some major causes of current Failures

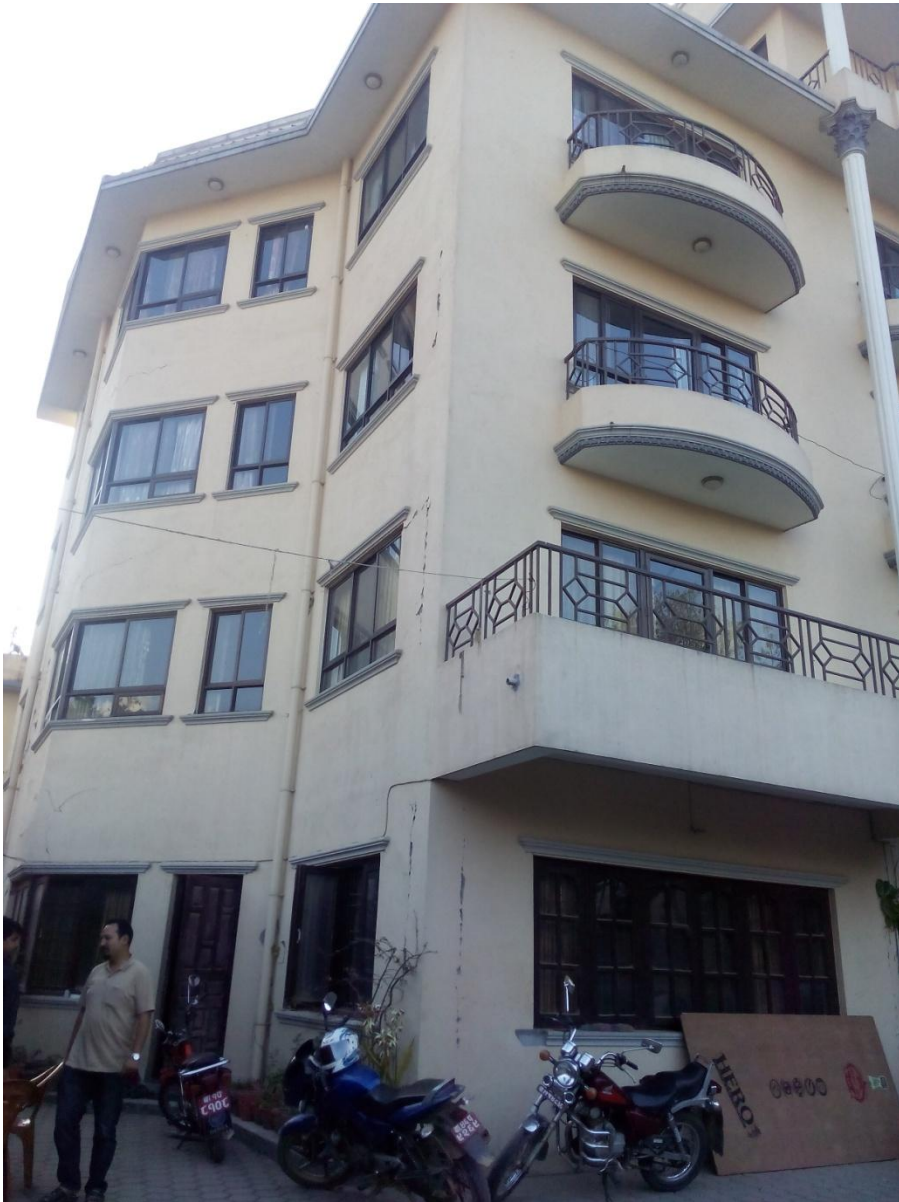
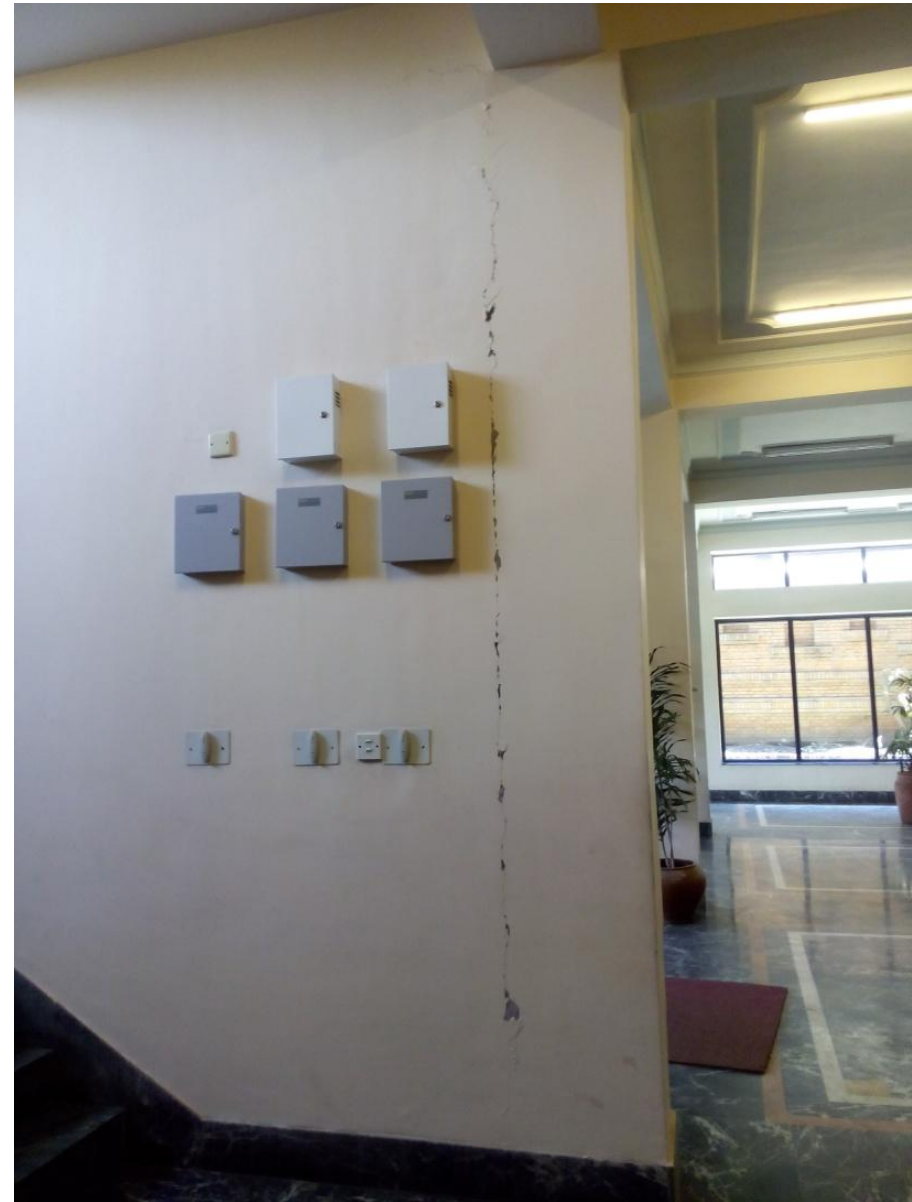
Vertical Crack between infill wall & column

- Horz. cracks just bottom of the beams
 - Repairable
- Horz. cracks between the top & bottom of beam
 - Repairable by inserting hard wood wedge at mortar between each brick
- Vert. crack in between column & wall
 - Repairable
- Vert. crack
 - Mostly non-repairable
- Diagonal crack
 - Repairable by inserting hard wood wedge at mortar between each brick
- Cross diagonal crack
 - Mostly non-repairable

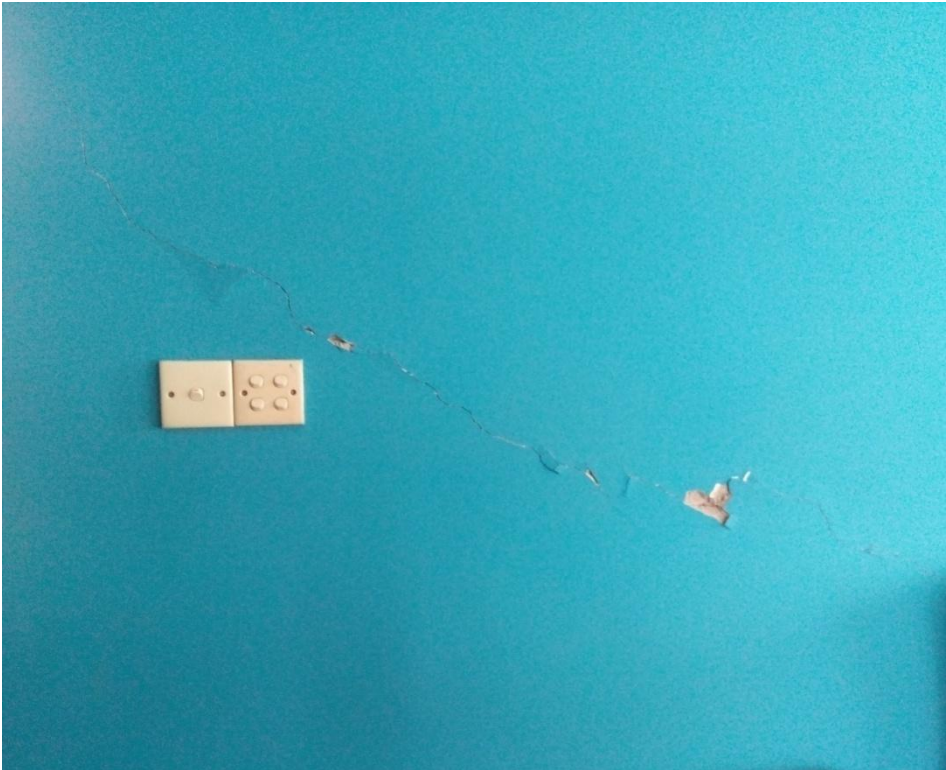
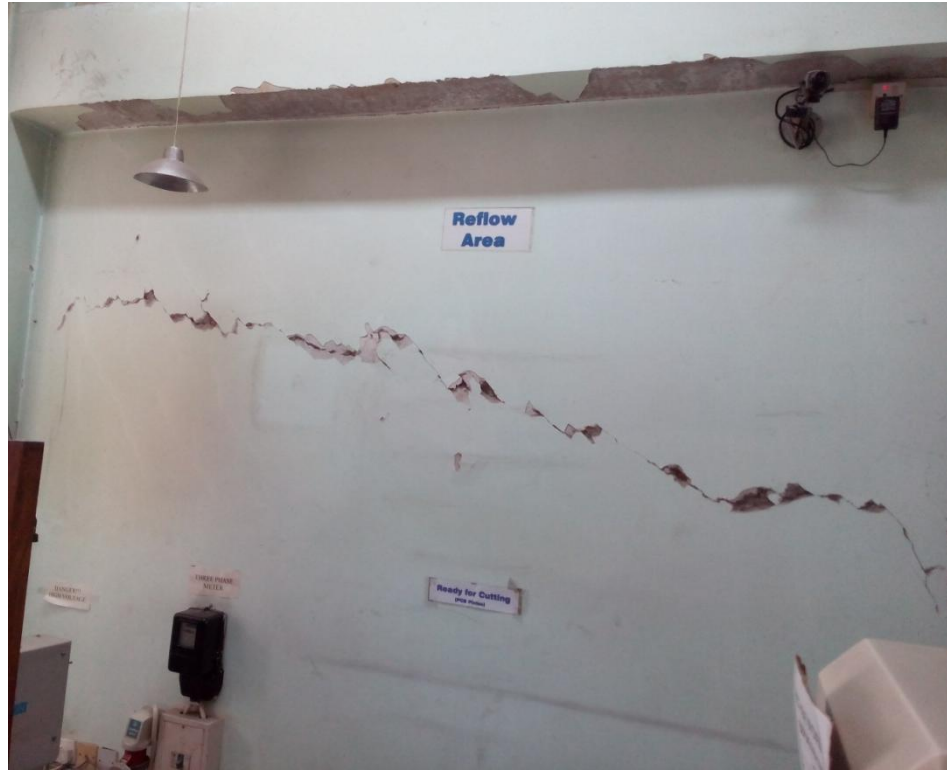
Diagonal Cracks

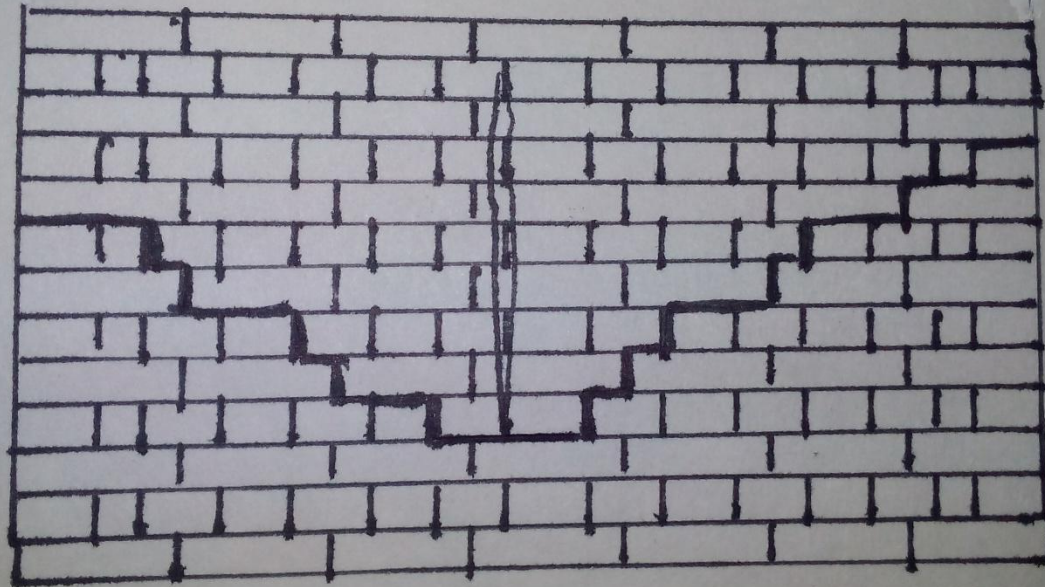
Repair of Vertical Crack

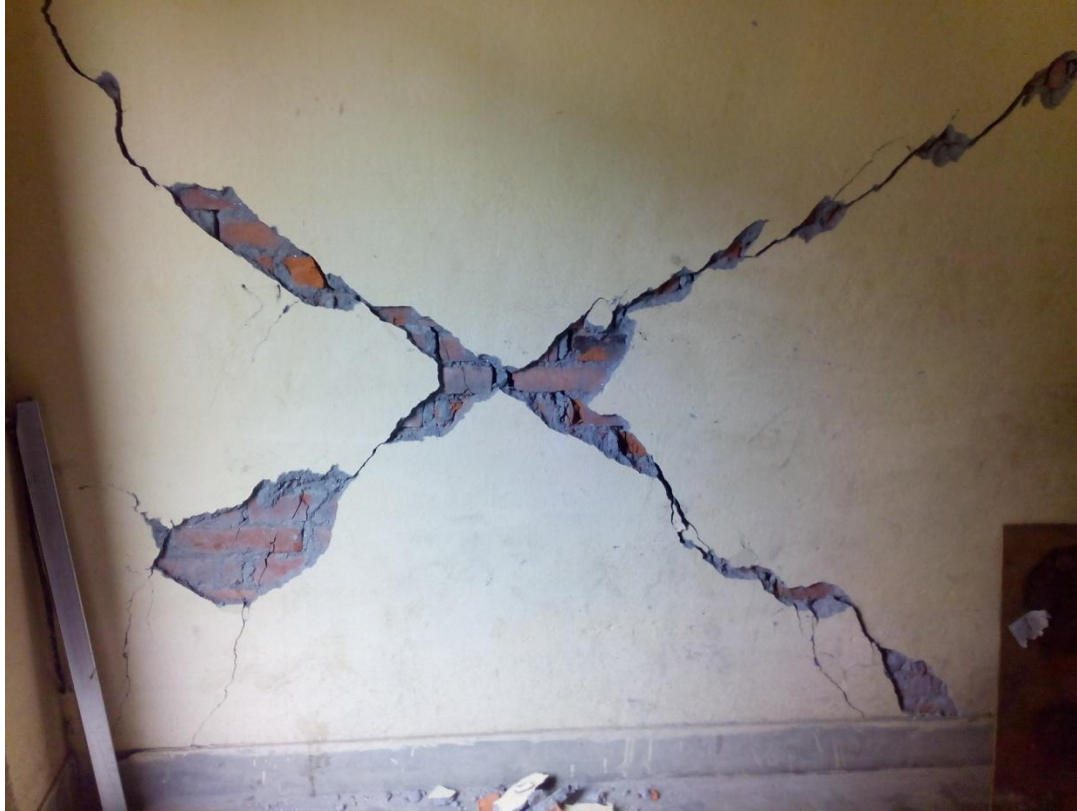
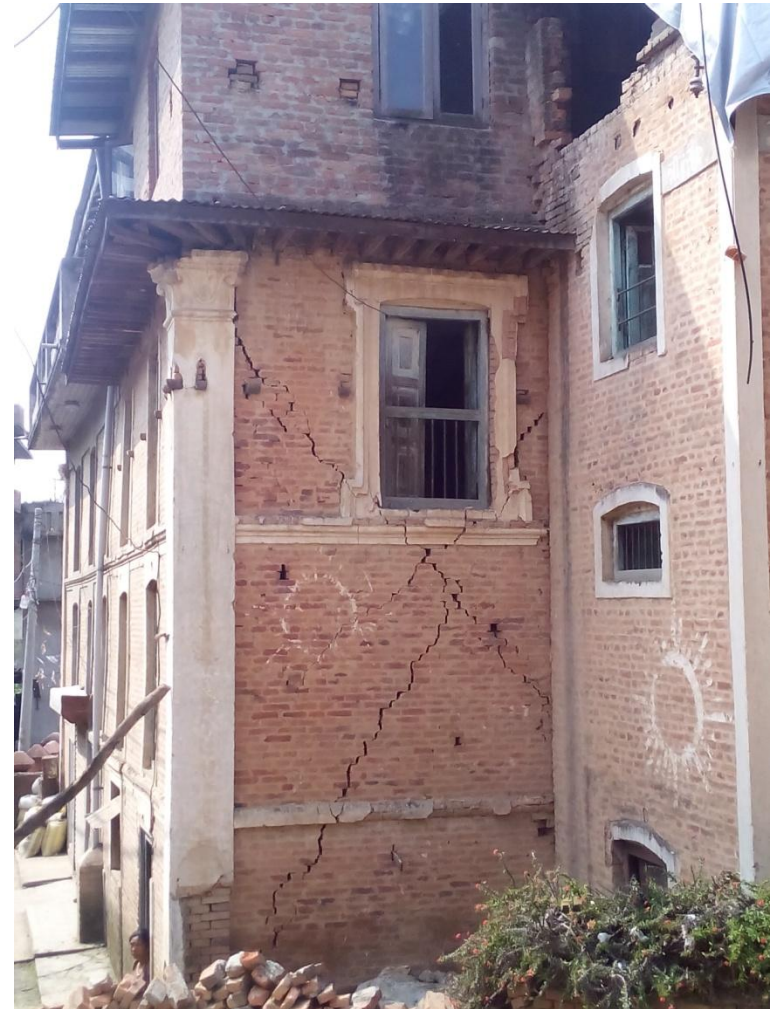
Cross Cracks

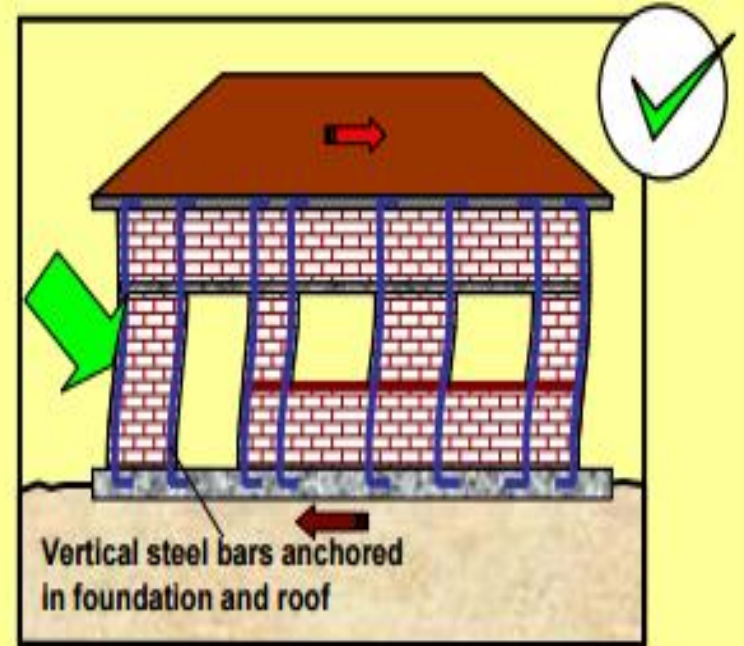
- Provide vertical steel bars at corners of wall segments and between openings to improve seismic resistance.

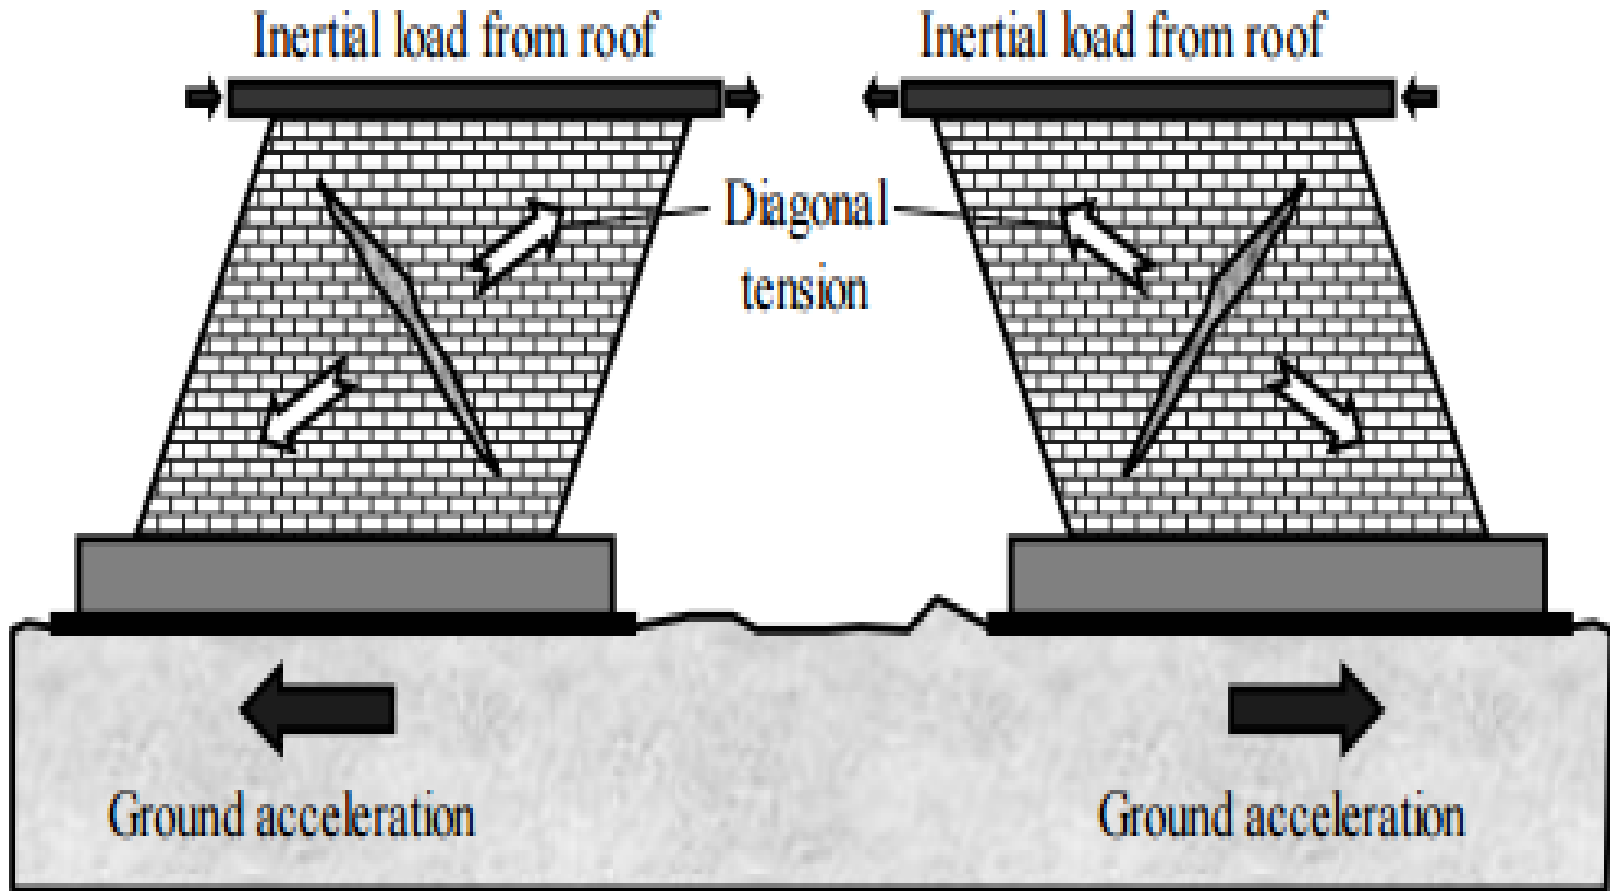
Diagonal Cracks

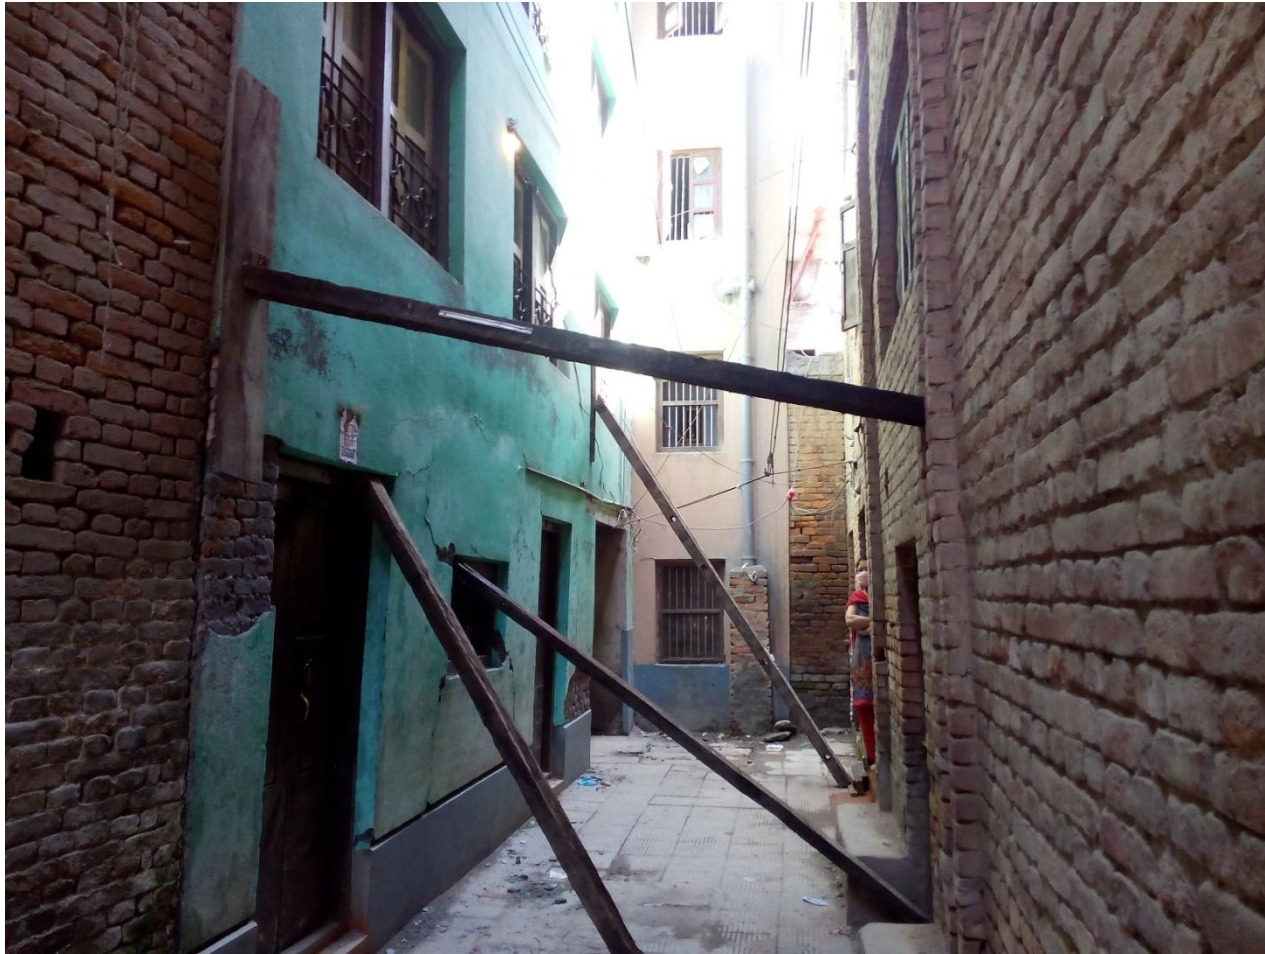
Temporary Supports

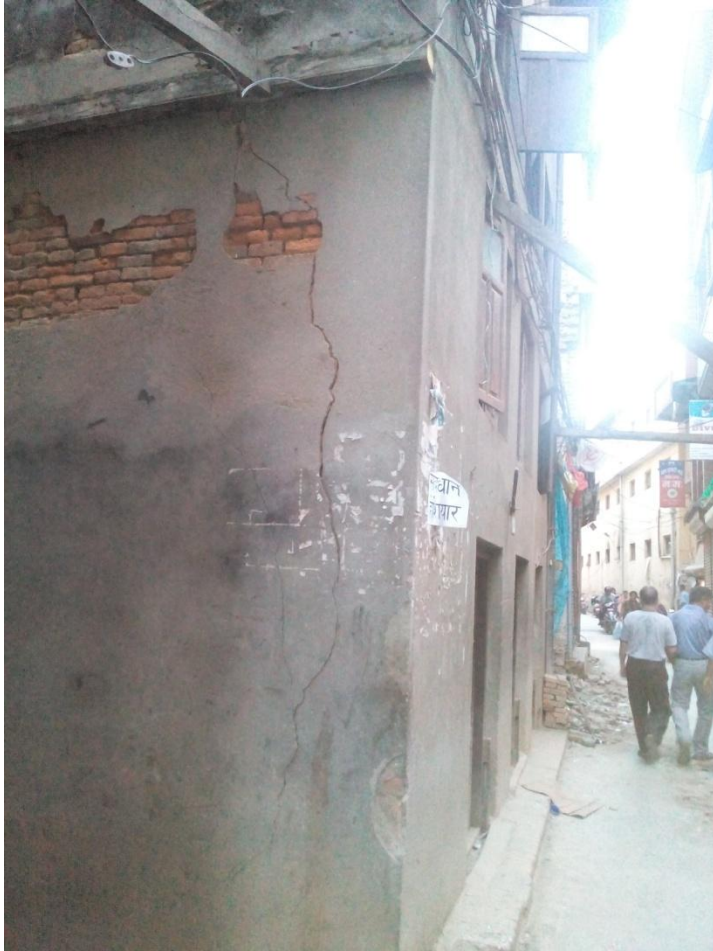
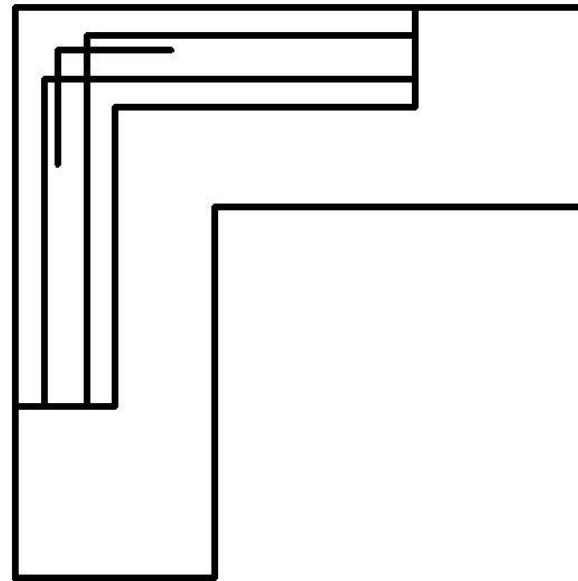
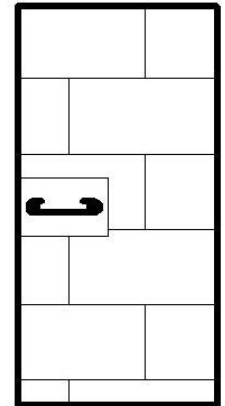
Masonry cracks at corner

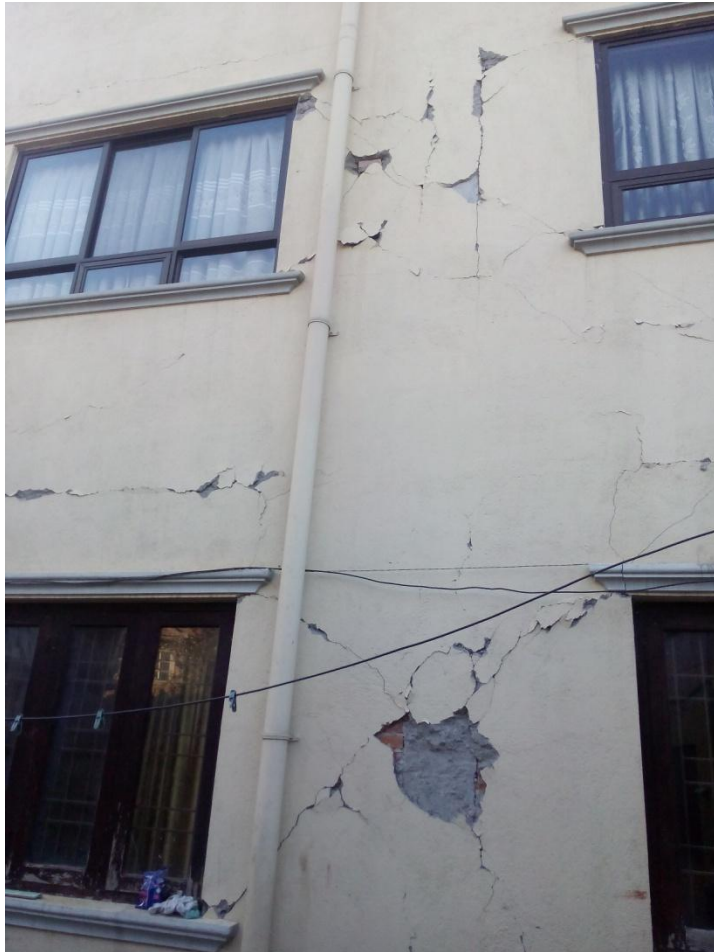
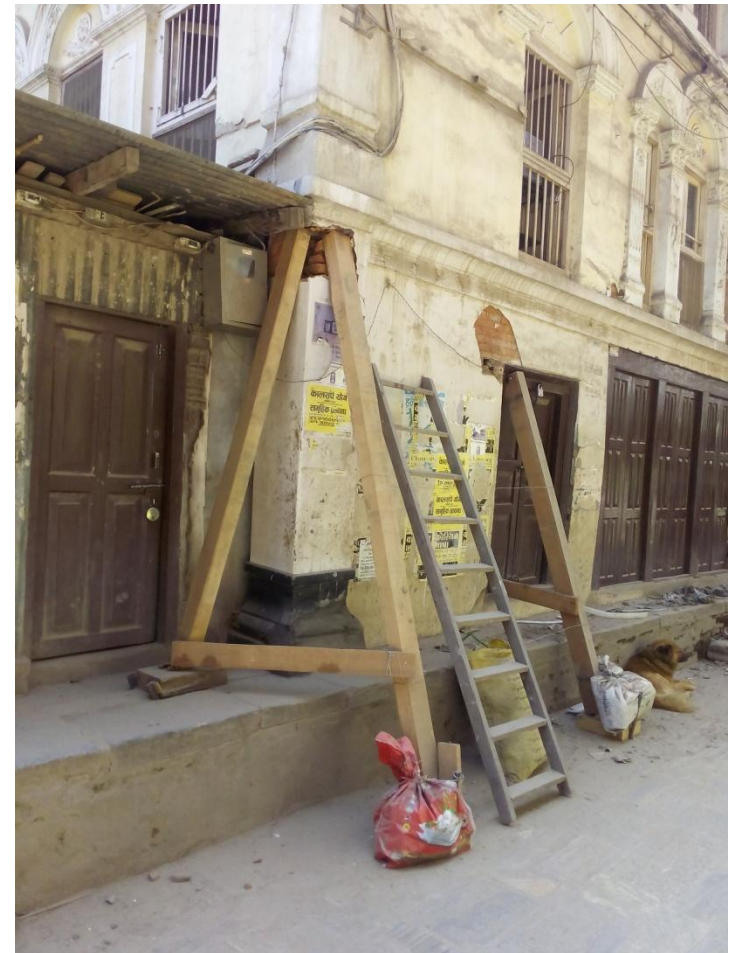
Different types of crack & Shoring

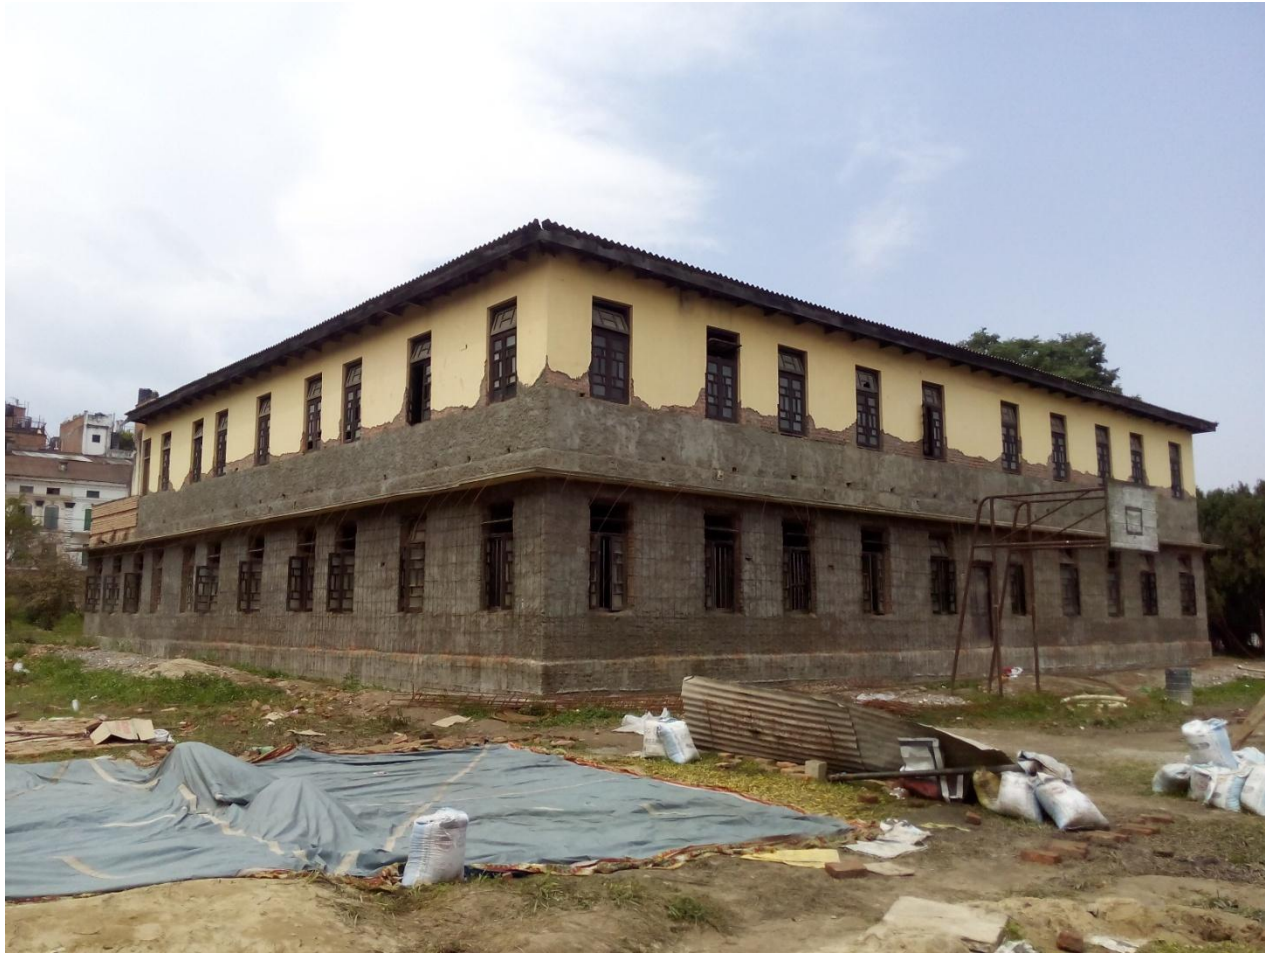
Strengthening of Wall

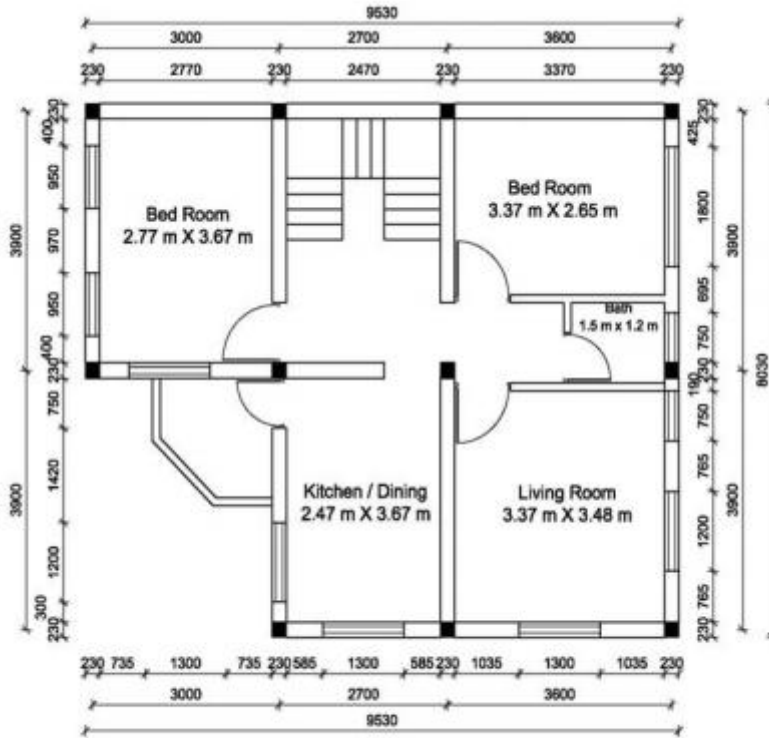
Retrofication

1st, 2nd, 3rd Floor Plan, Type 1 Building

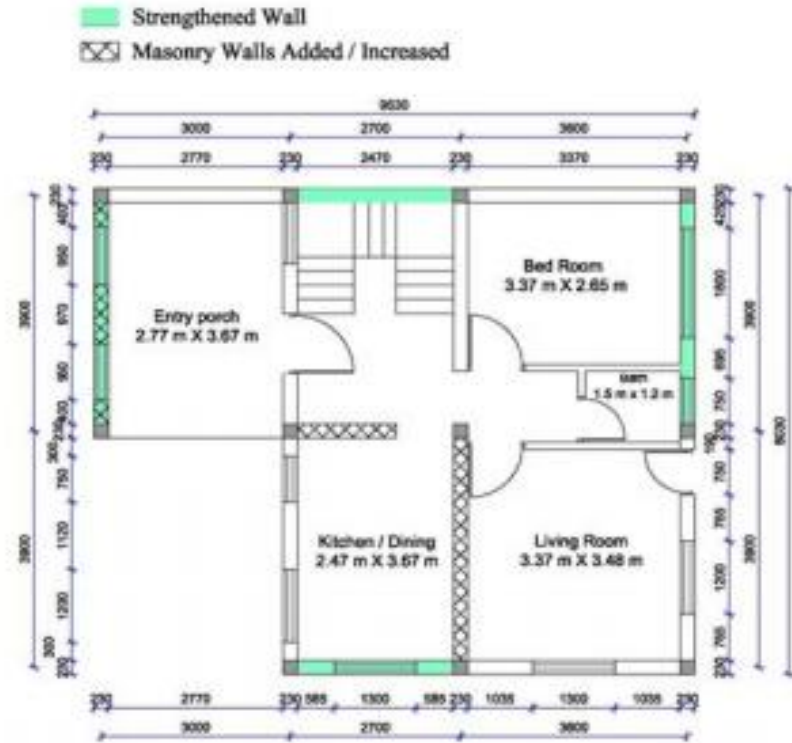
Building Type 1, Retrofitting Option

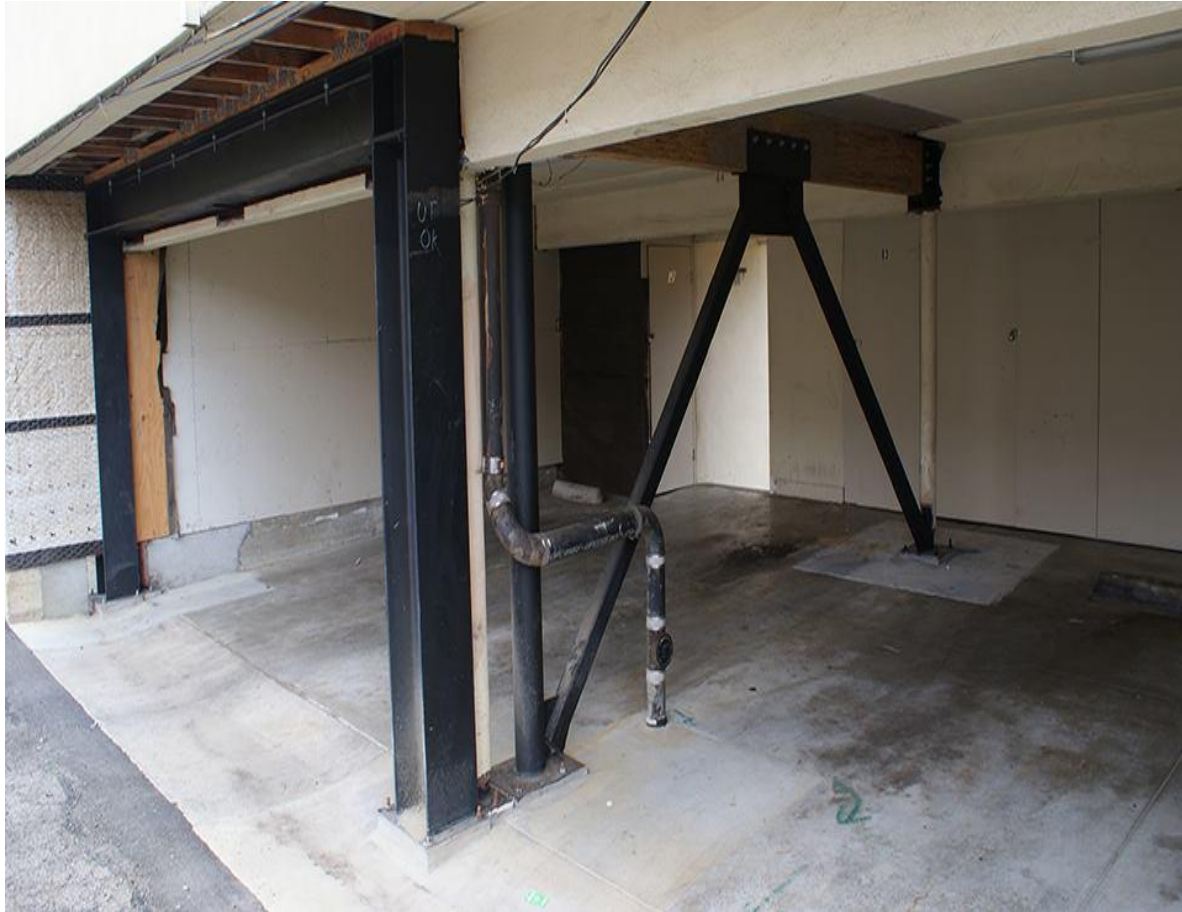
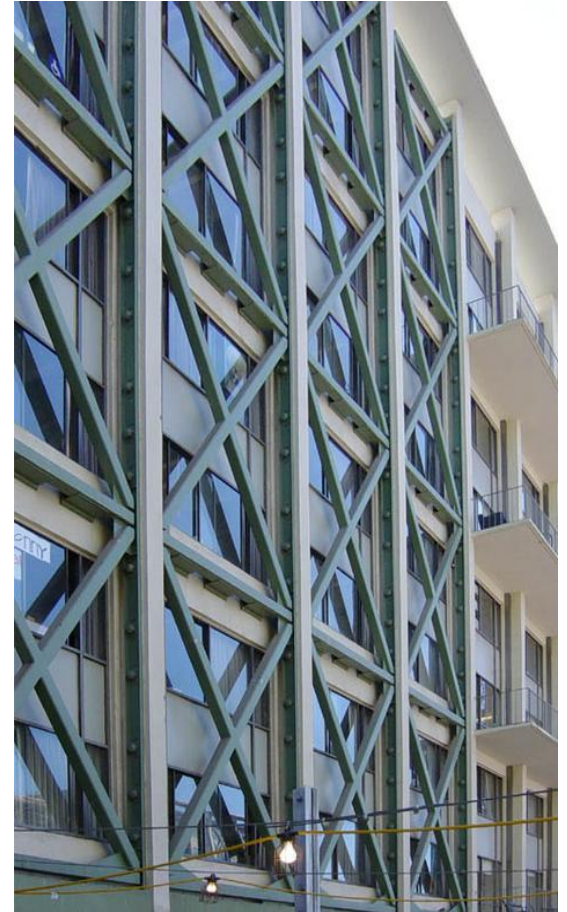
Heavy Retrofit for RCC Beam & Column

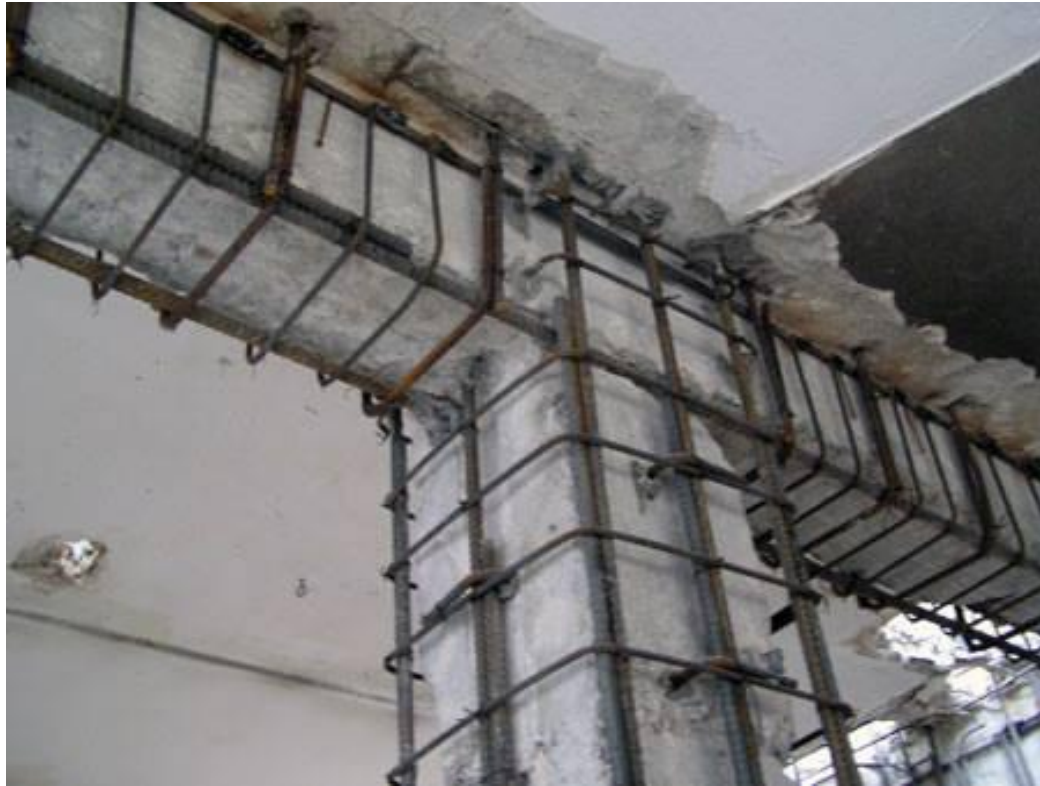
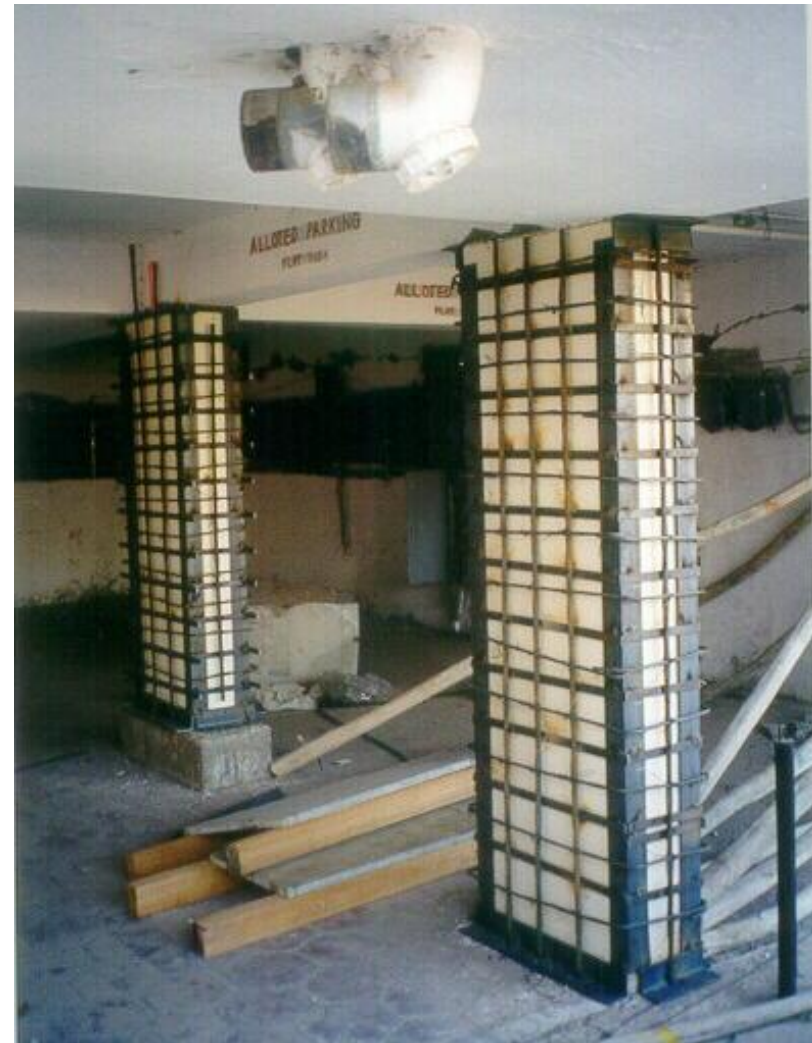
Retoficating

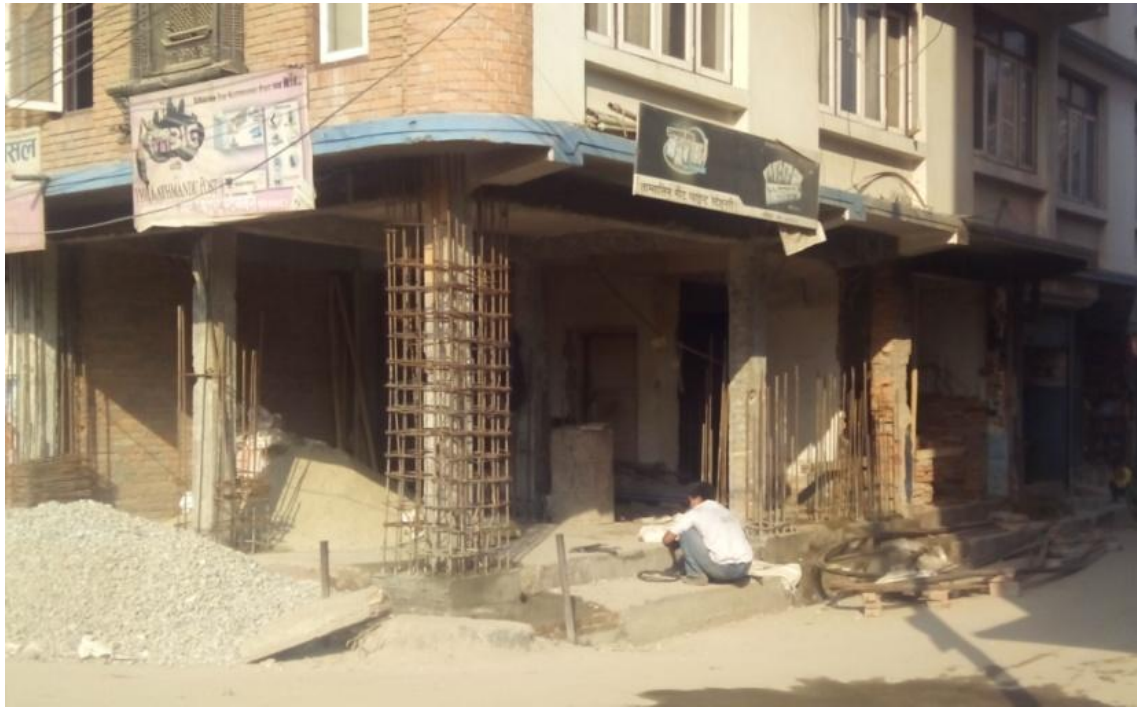
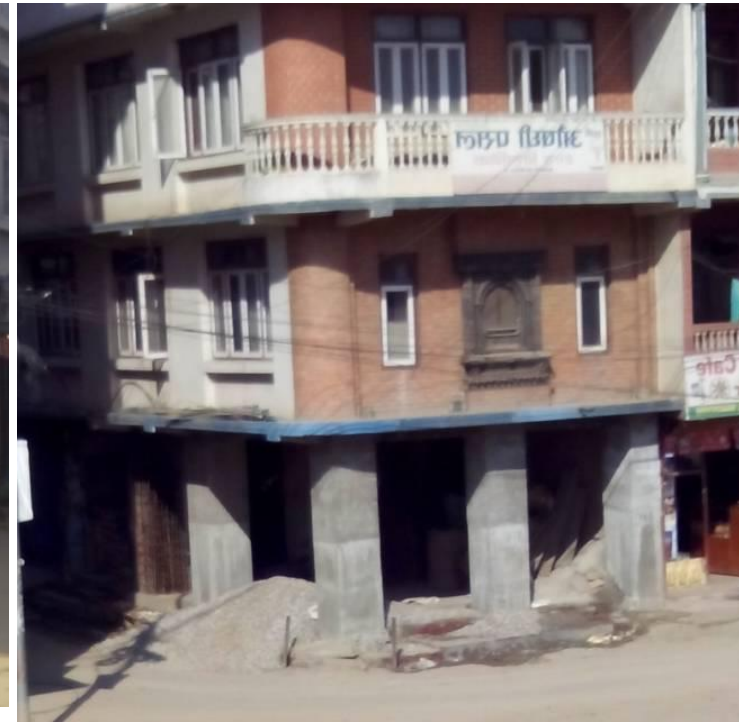
Strengthening for RCC Beam & Column

Retroficingating of Columns

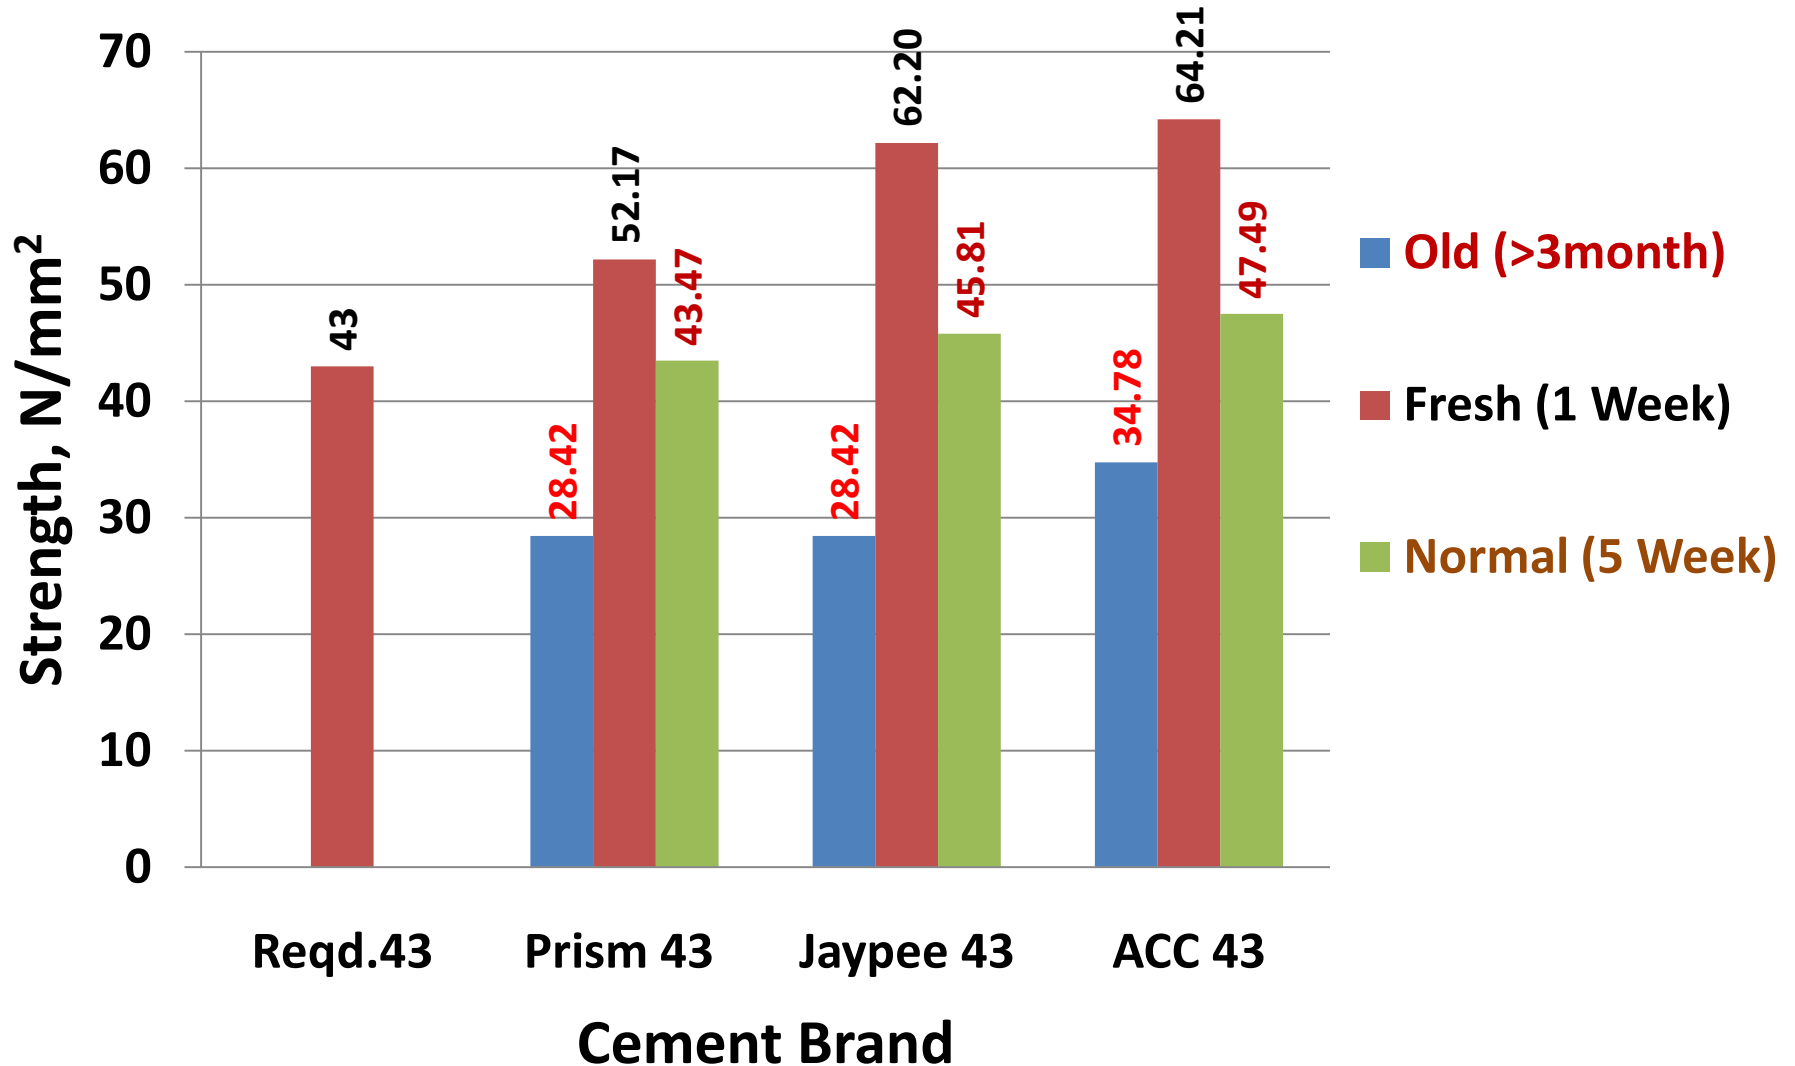
28 DAYS COMPRESSIVE STRENGTH OPC43

(STRENGTH VS PRODUCTION TIME PERIOD)

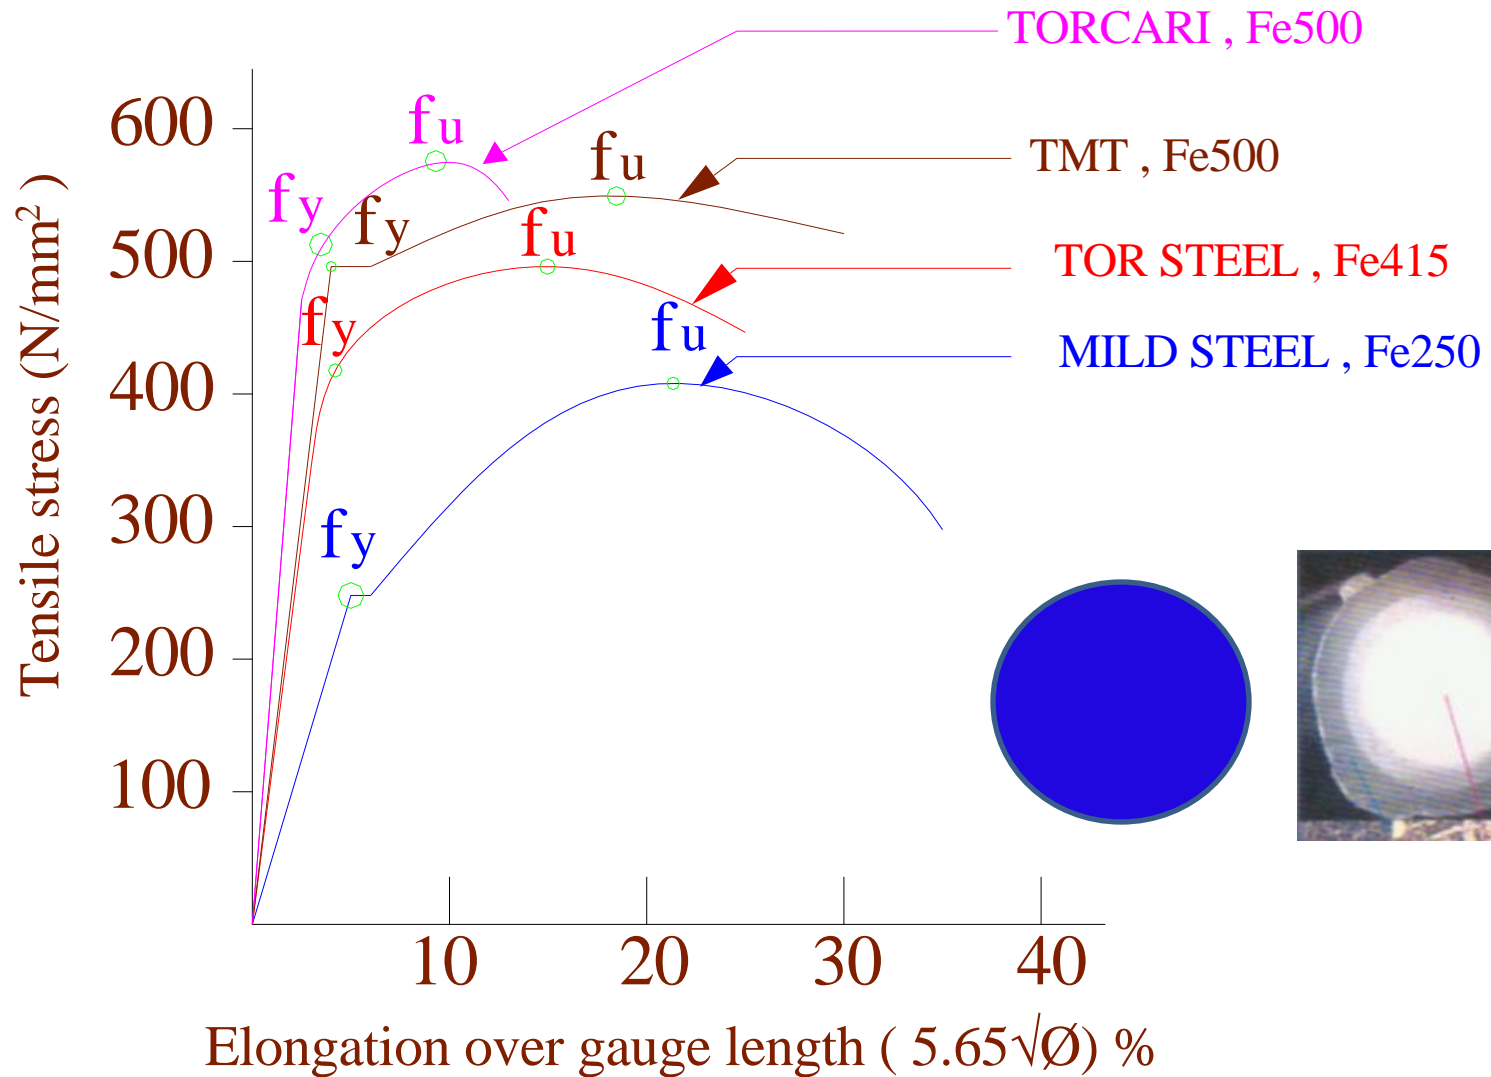
Mild, TOR, TOR Cari & TMT

VII. MILD, TOR, TORCARI & TMT
